MertonVision
67 Clarendon Rd, Colliers Wood, London, SW19 2DX

Structural Condition Report

Project number: 2190695
Status: Information
Revision: DRAFT 26/02/2020
Date: February 2020

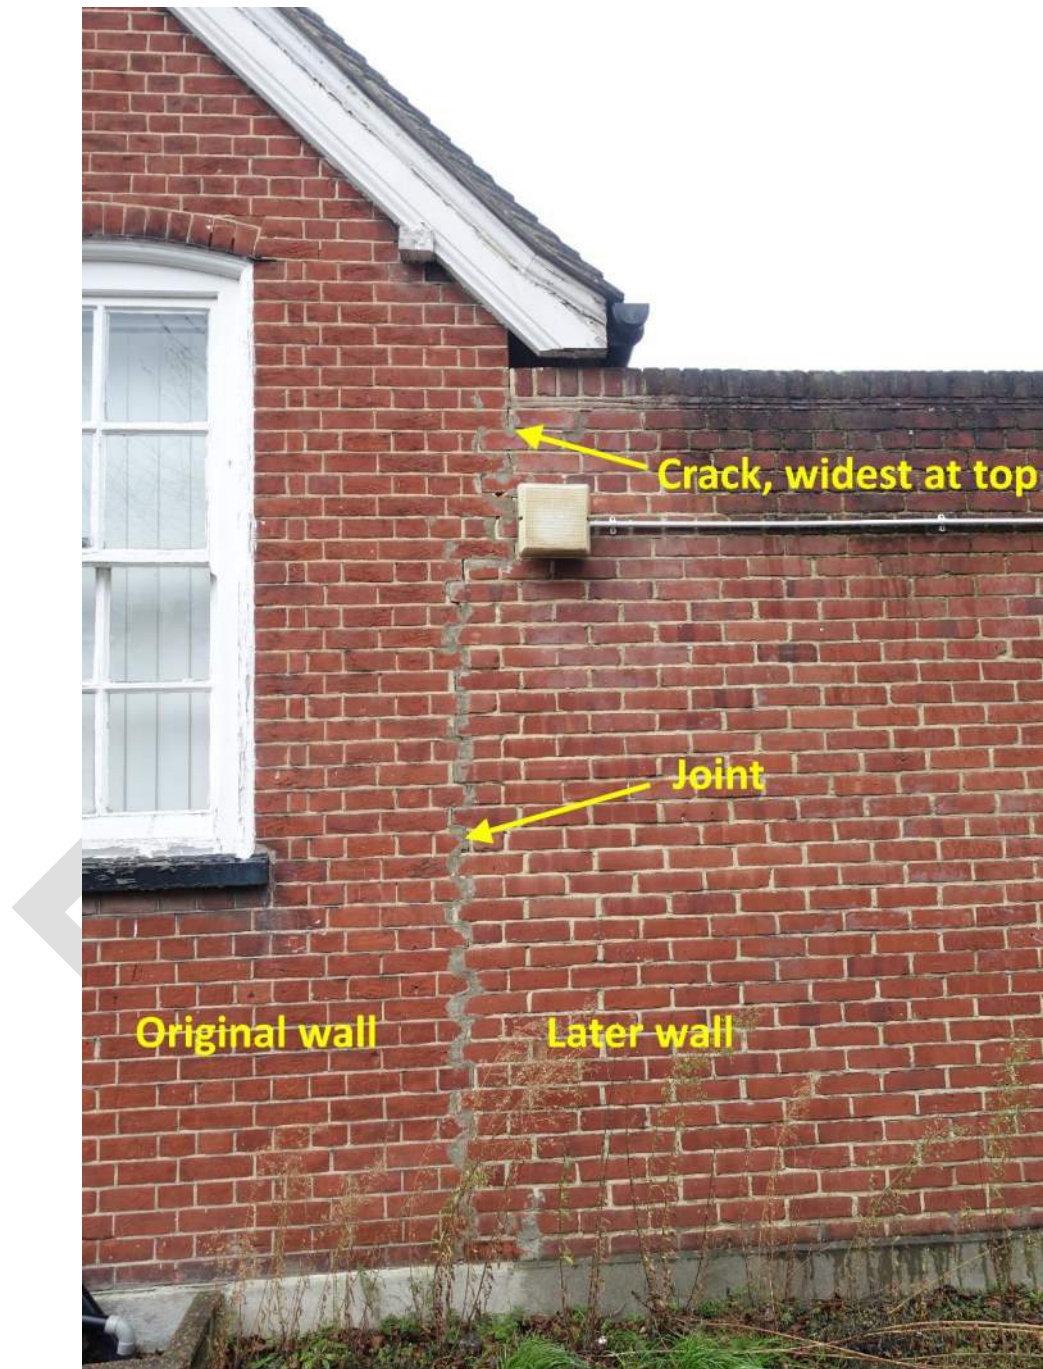
On the south flank wall, there has been movement between the extensions at both ends and the original building. The new brickwork was built bonded into the existing. Both joints have cracked. The crack widths are widest at the top, tapering to zero width lower down, implying some rotational movement of the wall.

Photograph 9: Cracked joint in south wall

2. Where cracks occur at the joints between newer and older parts of the buildings, they are likely caused by the settlement of the new wings. The cracks should be monitored over a long period, up to one-year, to determine whether the movement is continuing. If not, the cracks should be repaired using HeliBars. If movement is continuing, consideration can be given to forming a movement joint in the masonry. However, additional restraint on either side of the movement joint may need to be reinstated.

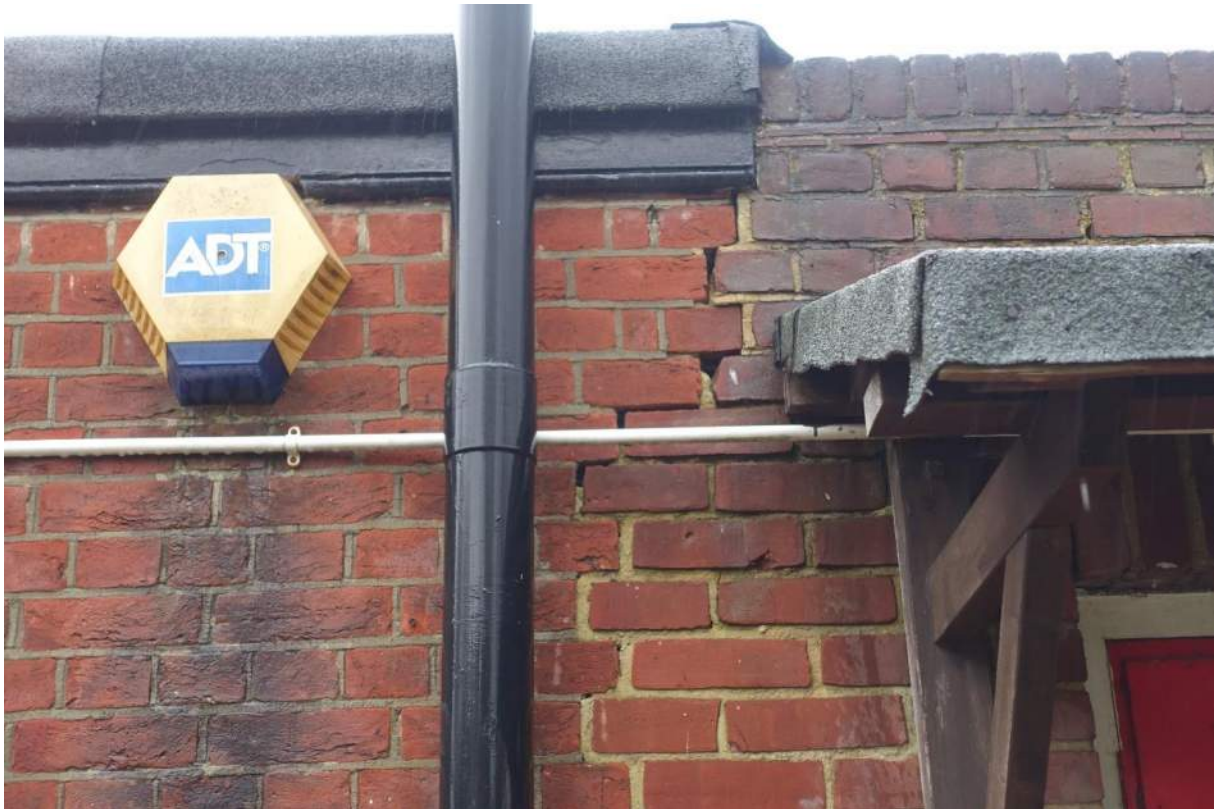
There is also cracking at high level on the west elevation, where newer brickwork joins older brickwork.

Photograph 10: Cracking and open joints on the west elevation

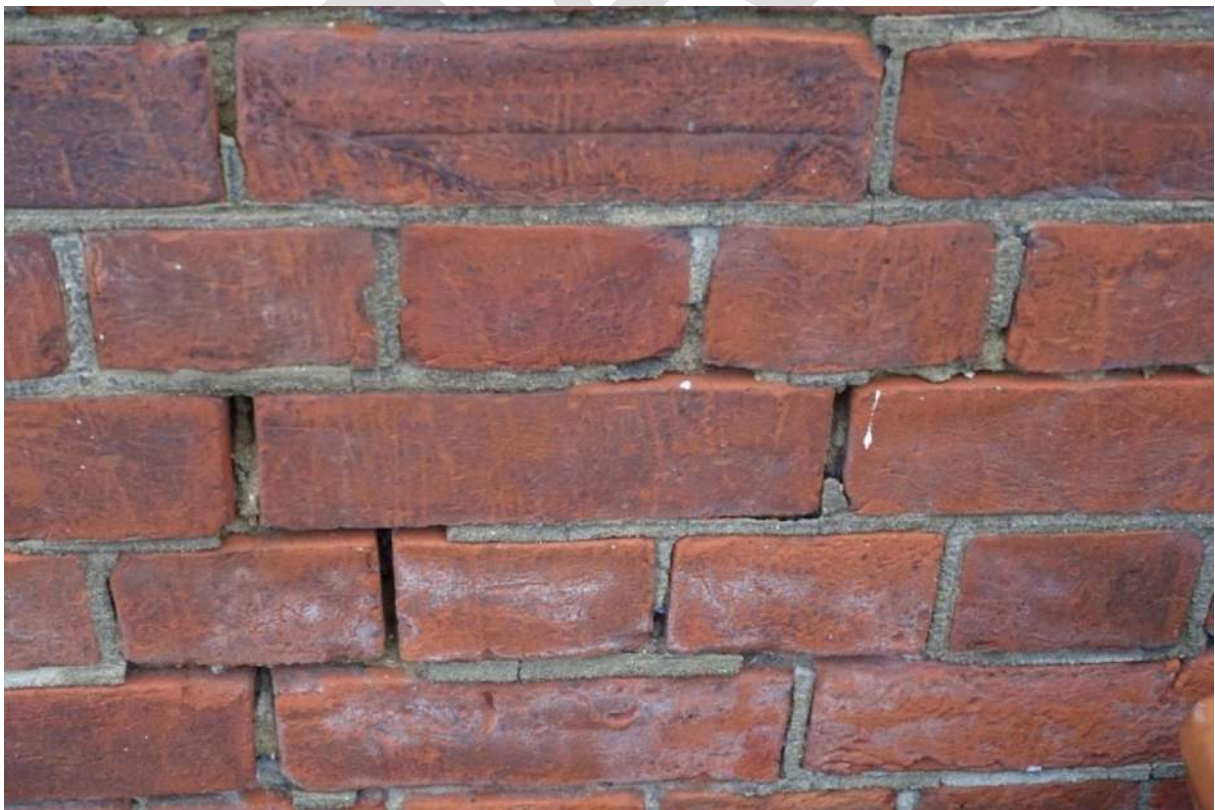
Some brickwork joints are missing mortar. This could allow damp to penetrate the wall.

Photograph 11: Missing mortar in brickwork joints

5. Redundant fixings/fittings in the external walls should be removed and the walls made good.
6. External brickwork should be repointed where necessary.

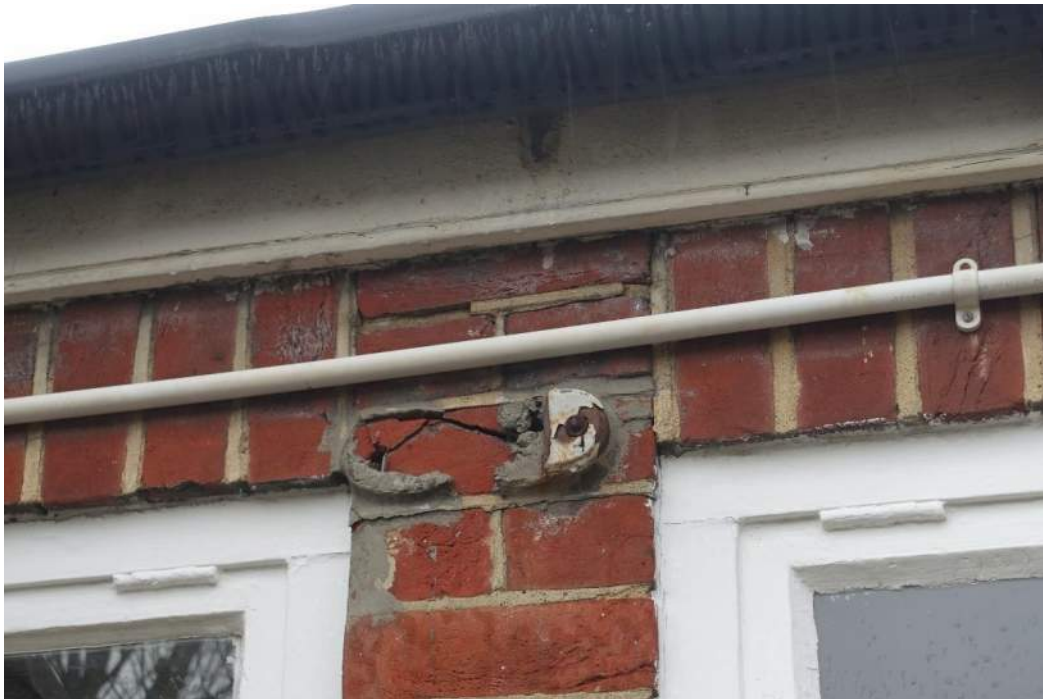
Cracking is present at a partially removed fitting.

Photograph 12: **Damaged brickwork at a redundant fitting**

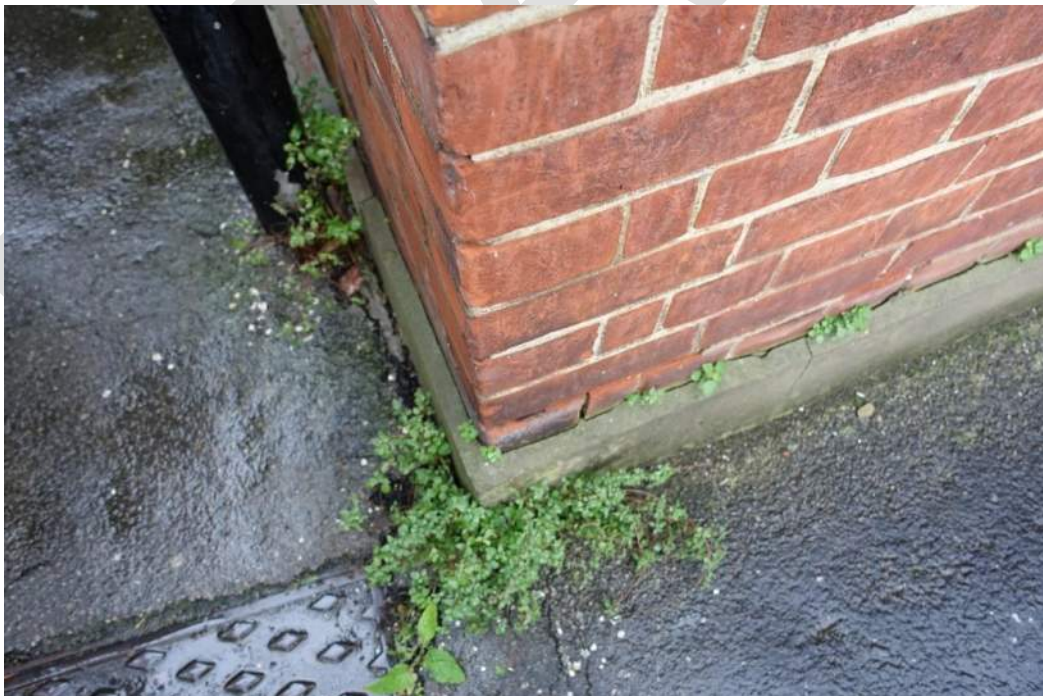
A render strip is present around the bottom of the external walls. At some locations, it has cracked at others, it has become detached from the wall, allowing rainwater ingress and plant growth.

Photograph 13: **Render strip detached from base of wall**

7. External render should be hammer tested and all debonded areas removed and replaced. The render should be removed locally at all cracks. If there are cracks in the substrate, these should be repaired as elsewhere; stainless steel expanded metal lathing should be fixed across the crack in the substrate before the wall is re-rendered.

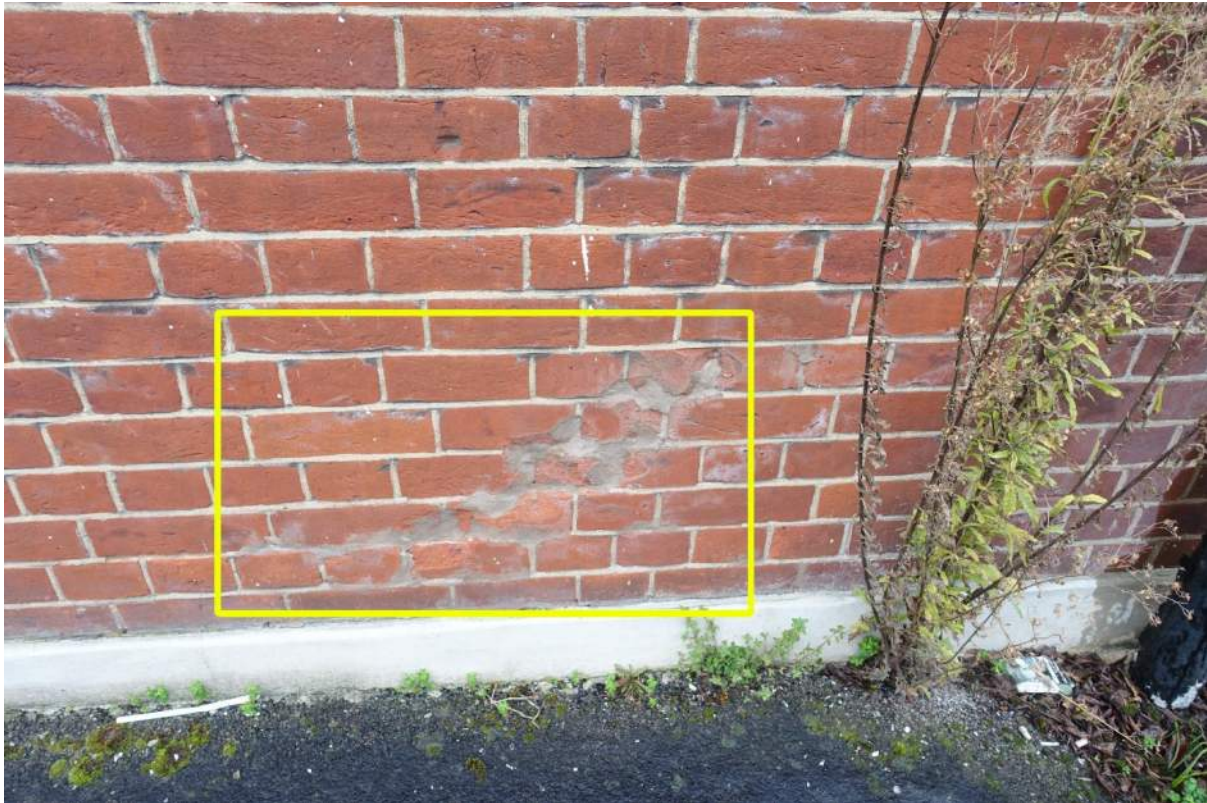
There are signs of spalled brickwork on the south elevation having had an attempted repair with mortar. The cause of the spalling is unclear. It could be frost damage or mechanical damage.

Photograph 14: Mortar repairs to spalled brickwork

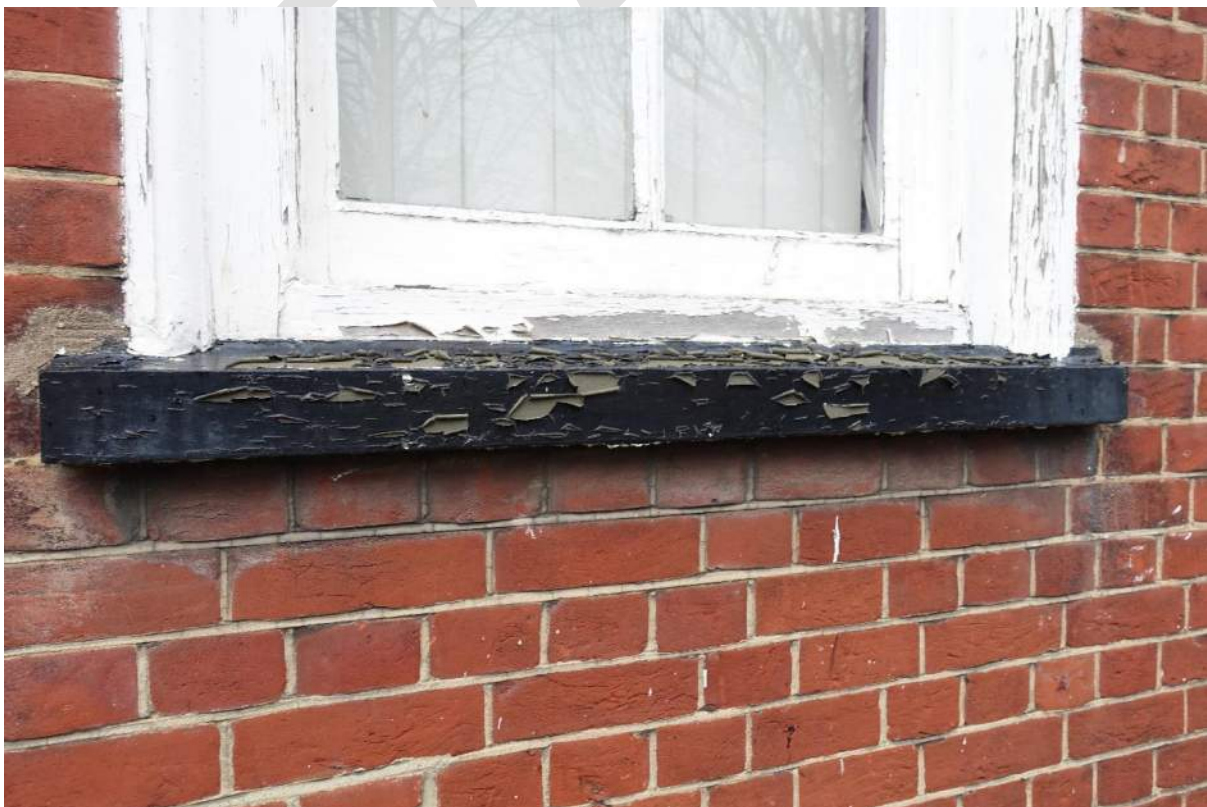
Timber doors, door frames and window frames and window cills are in poor decorative condition. Exposed timber is liable to rot.

Photograph 15: Flaking/missing paint on window frames and cills

10. External timber of all the buildings, windows, doors, barge boards, etc., should be reviewed by specialists and repaired or replaced as necessary. However, based on our observations, considerable repair and/or replacement is likely.

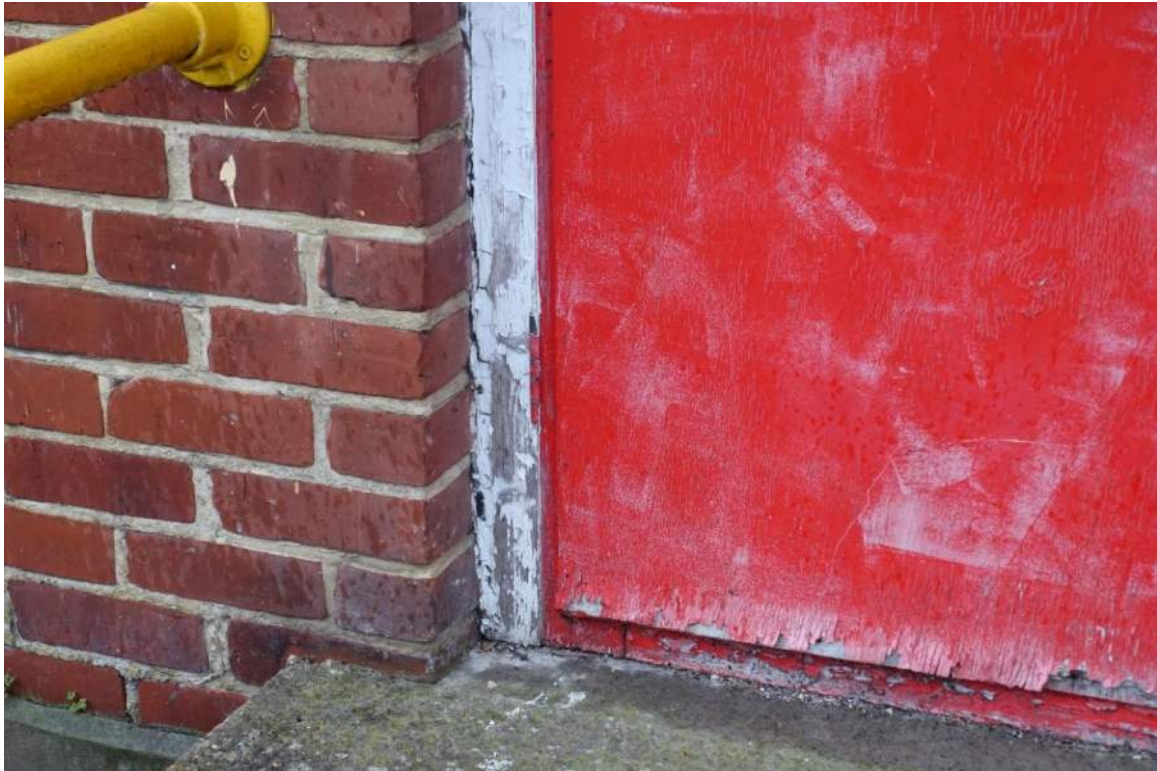
Photograph 16: Missing/flaking paint to door frame and door. The timber door is delaminating
Some window frame timbers are badly rotting.

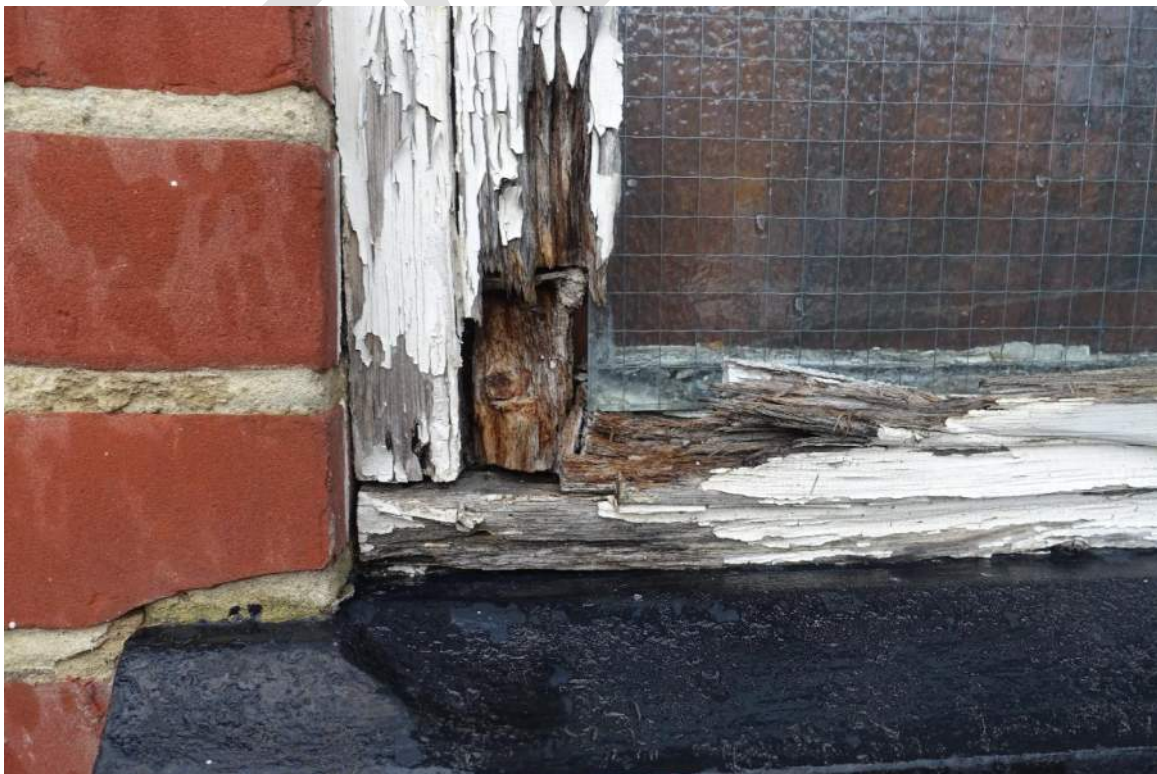
Photograph 17: Rotten window frame timbers

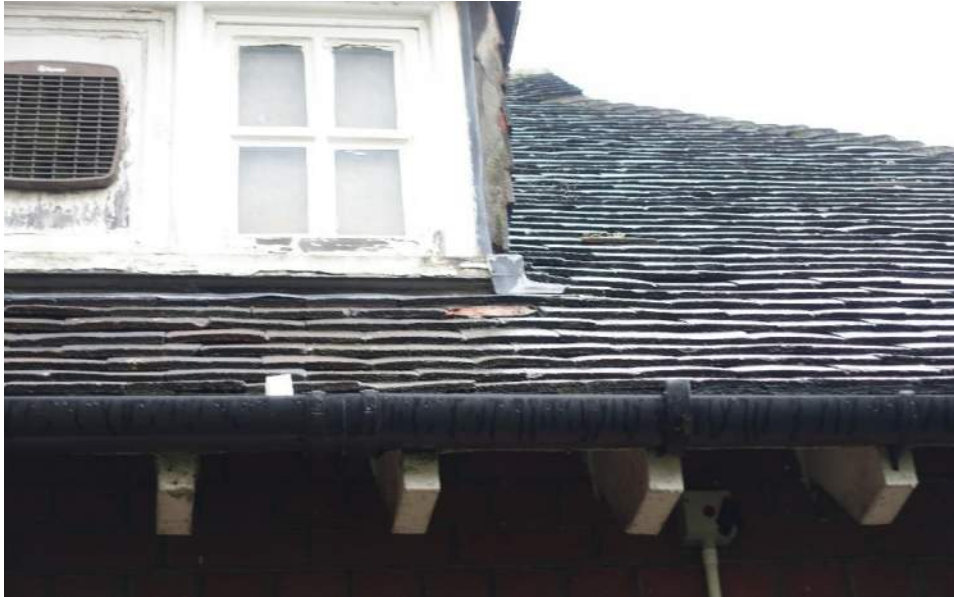
The clay roof tiles appear to be in poor condition and may be reaching the end of their life.

Photograph 18: Poor condition paintwork on dormer window. Roof tiling appears to be breaking up
Reportedly, the felt roof over the eastern plantroom and store was replaced about 8 years ago.

8. Generally, the condition of all roofs, flashings, gutters and downpipes should be reviewed by specialists and replaced or refurbished as necessary to ensure the buildings are watertight in the future. Based on the extent of the damp/water ingress observed, it is likely that extensive repairs or replacement will be required.

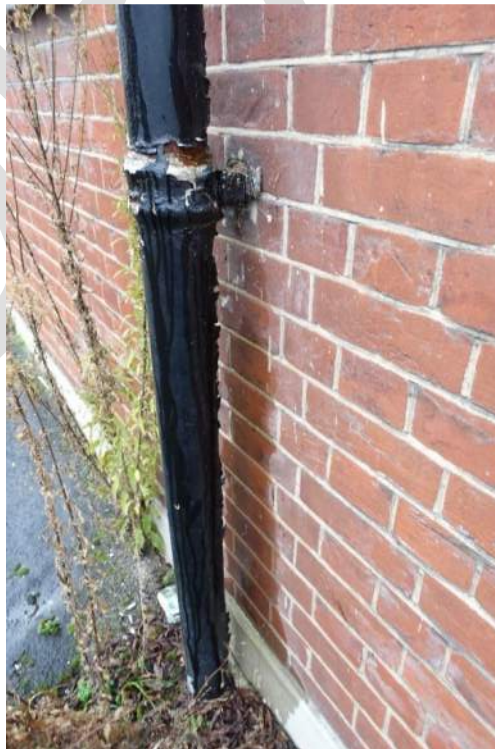
Cast-iron rainwater downpipes are leaking. The metalwork is rusting. Rainwater from one leak was seen to be running down the outside of a downpipe before dripping down onto the brick wall, risking damp penetrating the building and frost damage to the brickwork if not rectified.

Photograph 19: Leaking/rusting rainwater downpipe

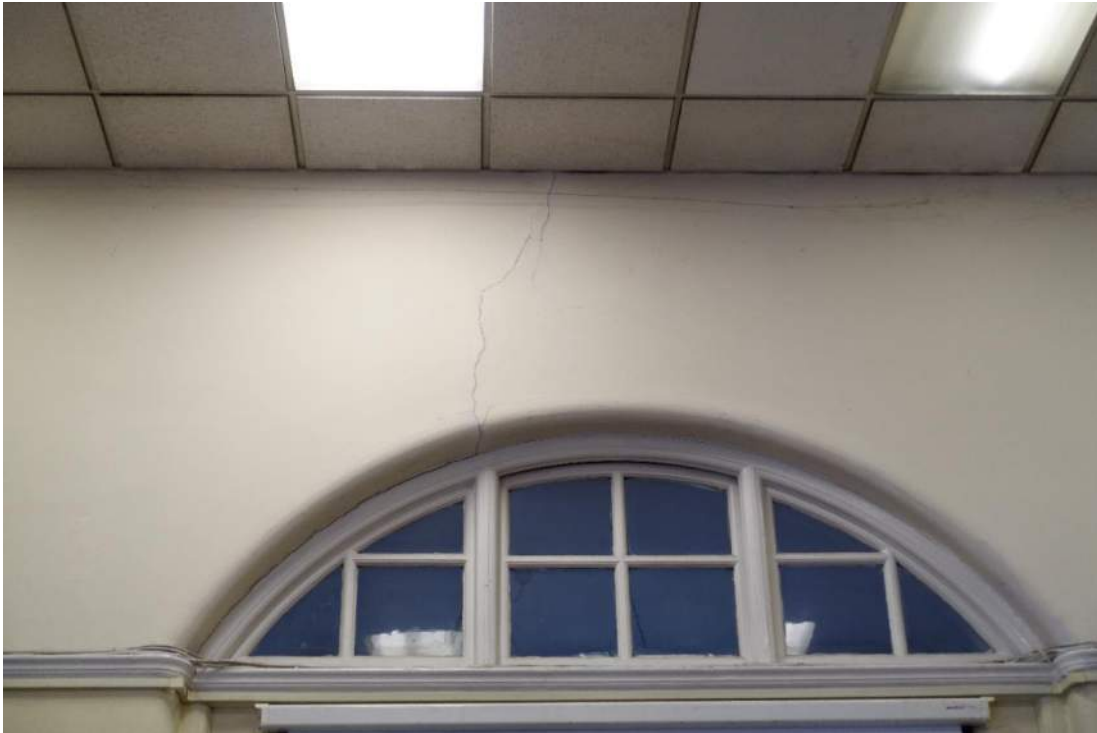
Two of the arches in internal walls bordering the main hall have cracks.

Photograph 20: Cracked arch in main hall

It is unclear whether the cracks are only in the plaster finish or are also present in the structure behind. The width of the cracks at the time of the visit did not cause any immediate concern.

4. Minor internal cracks in plastered walls can be treated by removing the plaster locally, if there is a minor crack in the masonry substrate, expanded metal can be fixed across the crack before the wall is re-plastered. More serious cracks should be repaired using HeliBars.

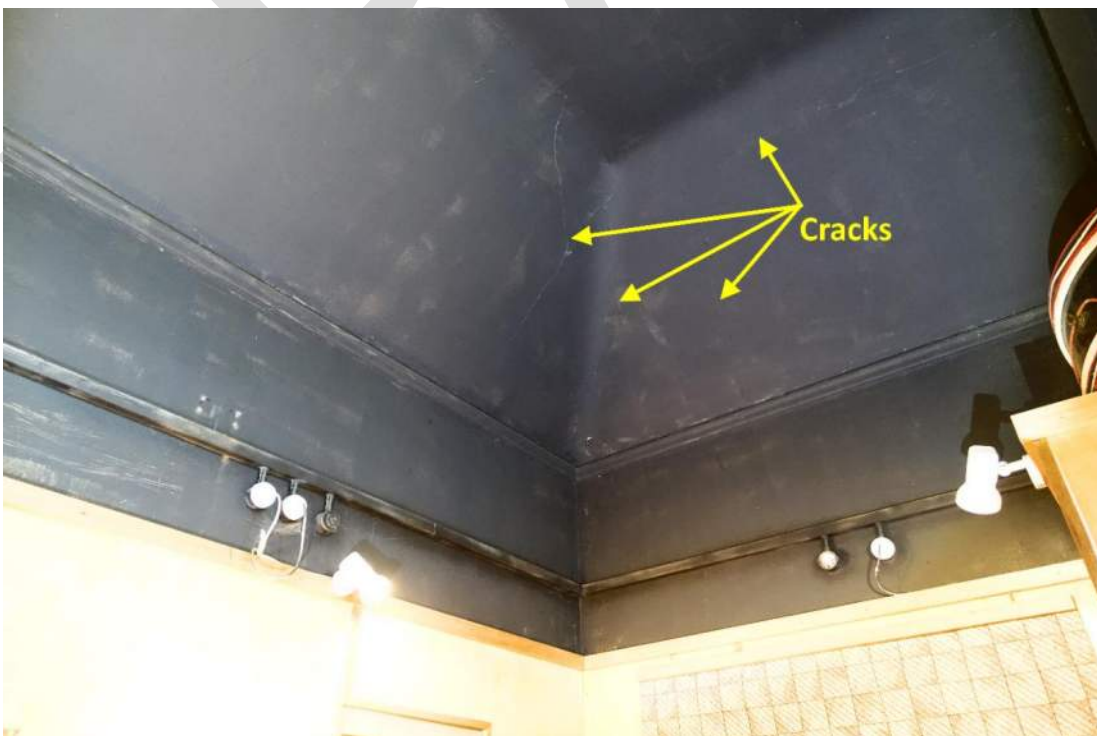
There is some cracking in the ceiling over the bar. It is mostly hairline. Its cause is unclear.

Photograph 21: Cracking in bar ceiling

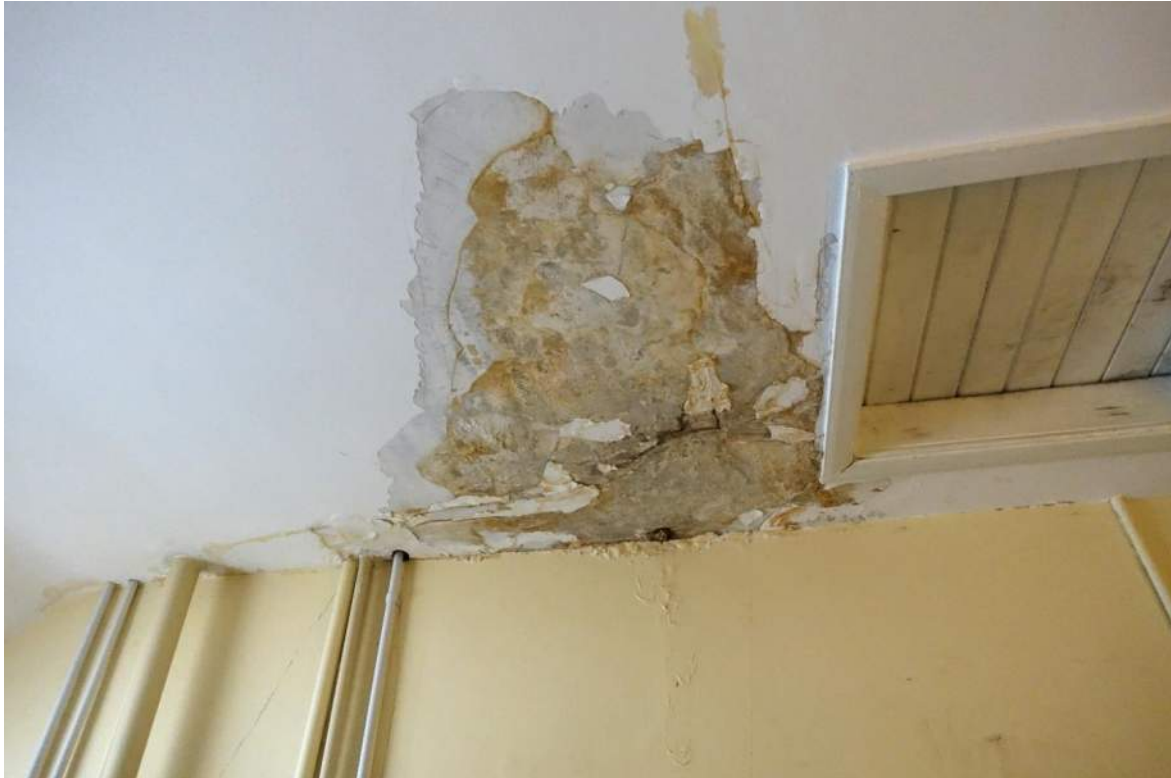
There is evidence of there having been significant damp penetrations through the ceilings at several locations in the building.

Photograph 22: Apparent damp damage in the ceiling over a first floor office

9. Where significant water leaks have already occurred, if not already undertaken, the condition of timber in the vicinity should be checked for decay. A specialist timber report should be obtained on the condition on the timber in all roof spaces. From the evidence of historical roof leaks and the photograph within the Emily Villa roof space, significant decay may be present. Timber treatment is likely to be required and significant quantities of defective timber may need to be replaced.

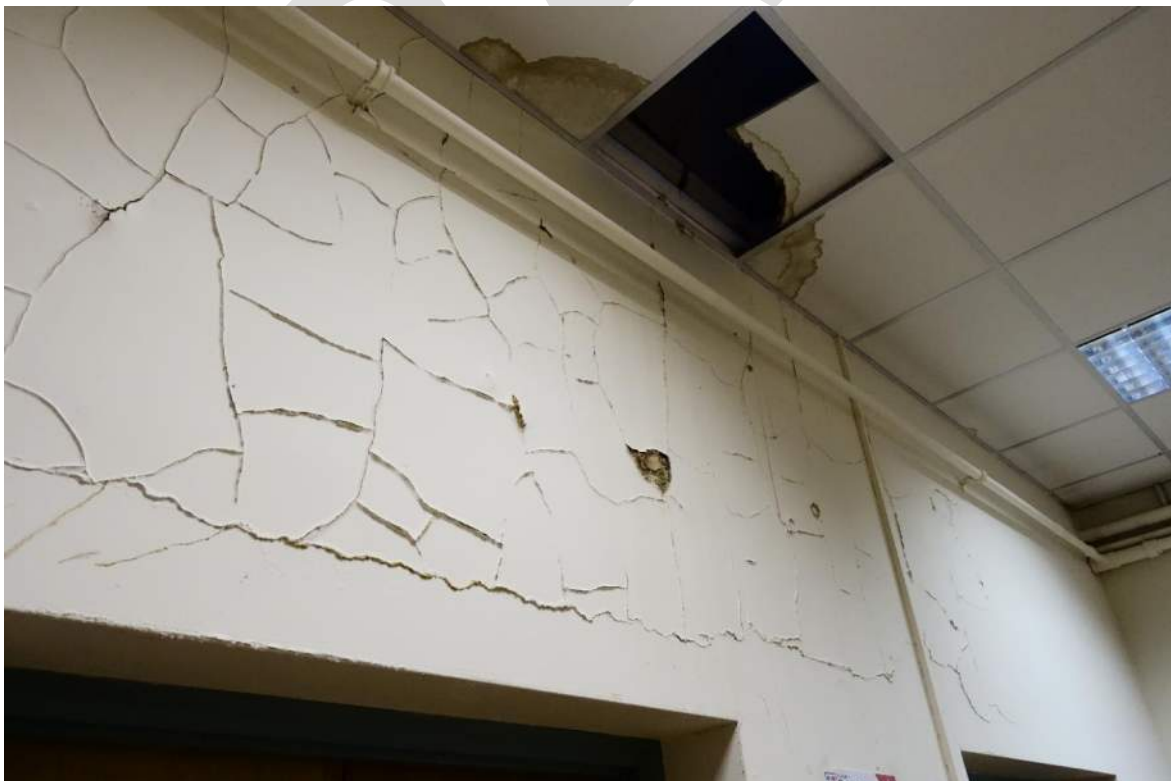
Photograph 23: Evidence of damp in the ceiling of a ground floor multifunction room

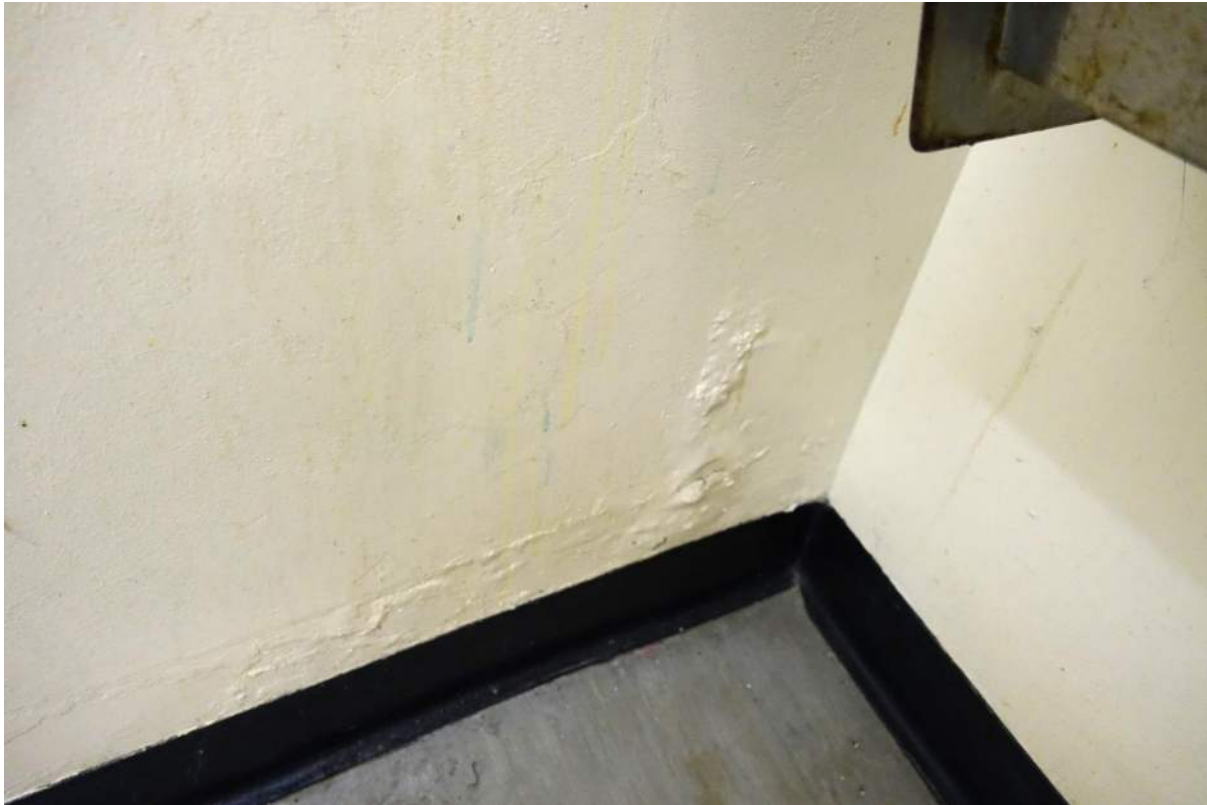
Paint damage within the toilets may be due to rising damp.

Photograph 24: Paint blistering within the Gentlemen's toilet may be due to damp

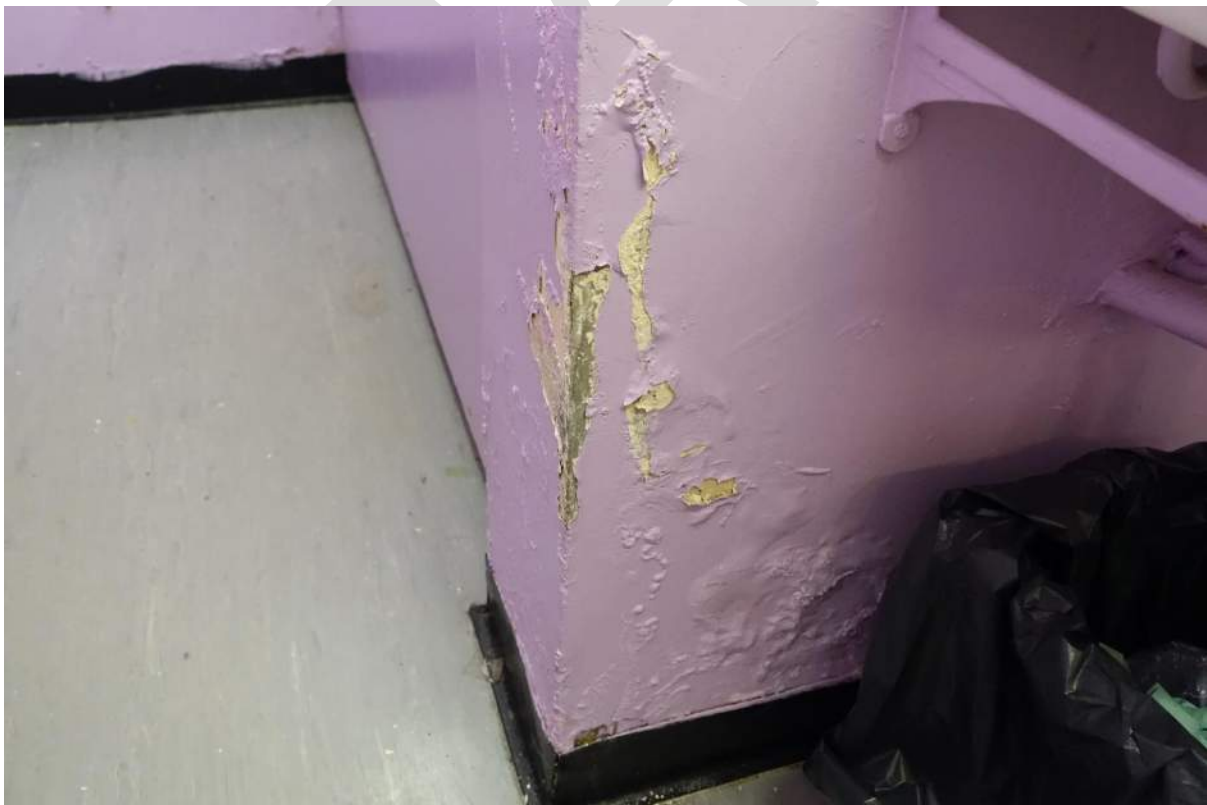
Photograph 25: Signs of damp within the Ladies' toilet

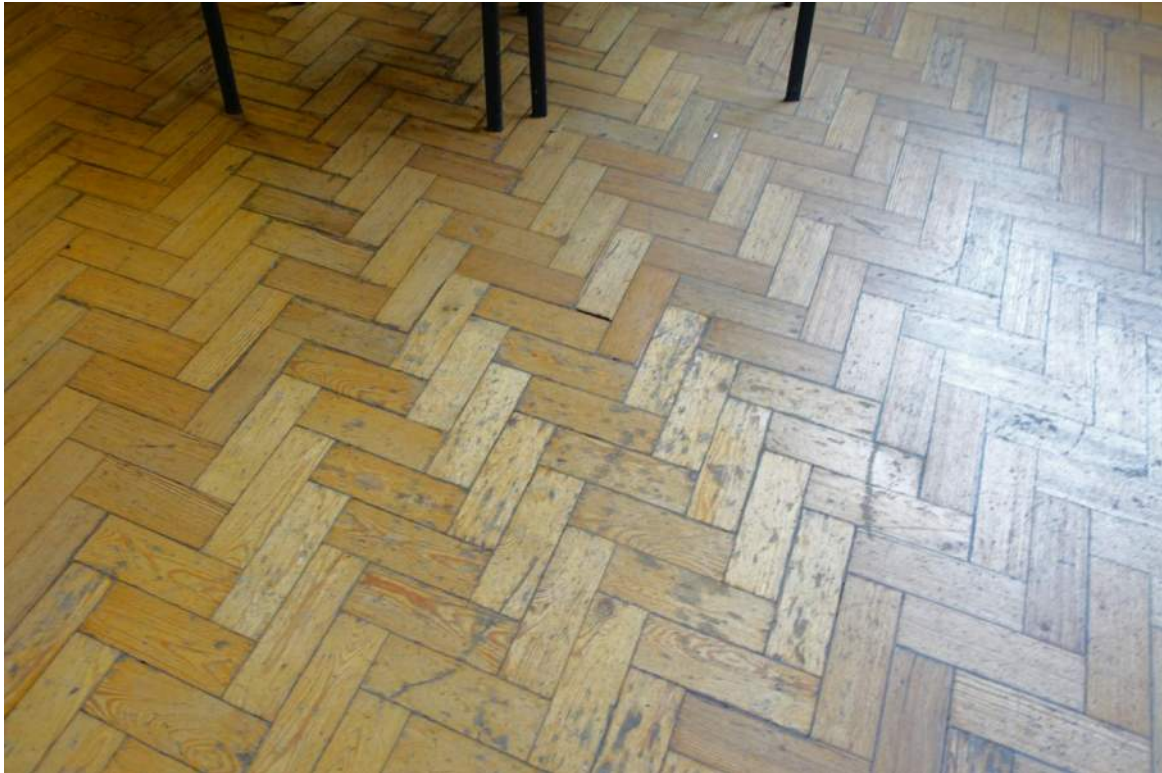
The timber parquet floor appears worn, possibly due to repeated sanding and local damage.

Photograph 26: Worn timber parquet floor in the main hall

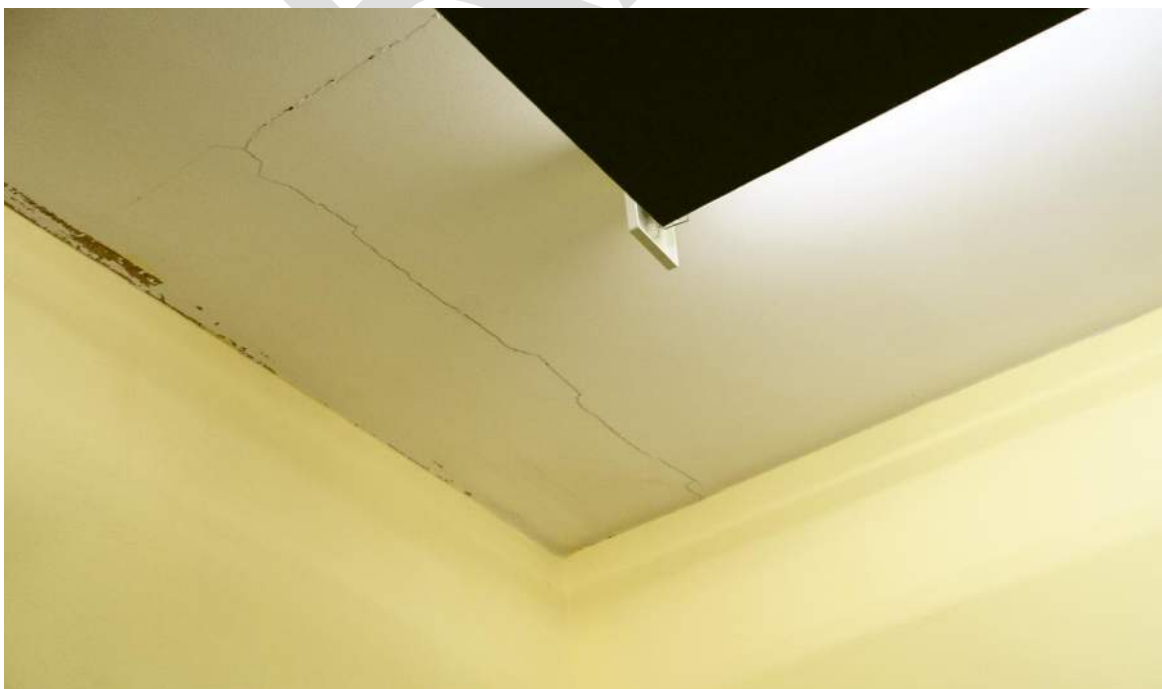
This is the newest building and appears to be generally in good structural condition. Some minor cracking is present but didn't cause concern.

Photograph 27: Minor ceiling cracking

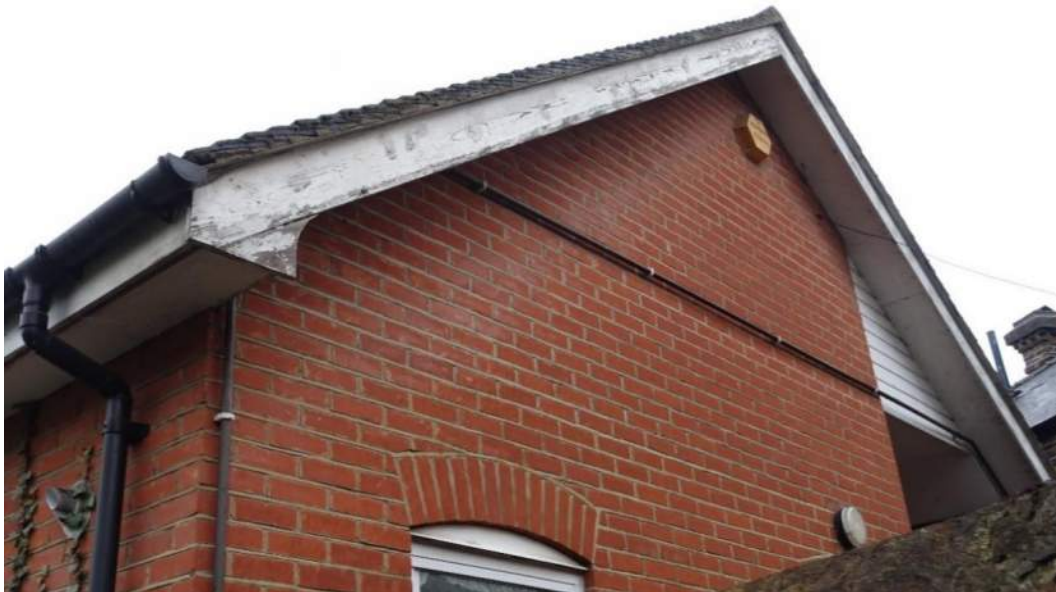
Roof timber barge boards are overdue for repainting. Some bare timber is exposed to the elements, risking rot.

Photograph 28: Barge boards need repainting

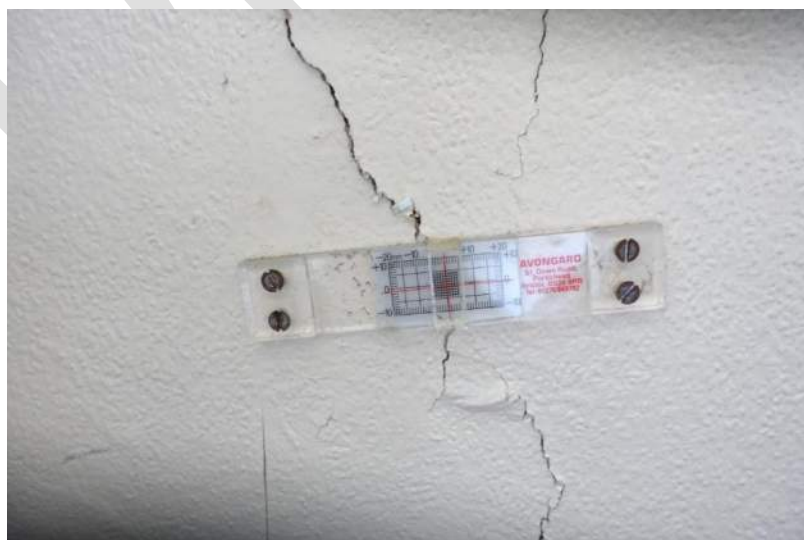
This building shows evidence of extensive cracking and historical crack monitoring. EWP have heard a report from staff that a drain was the cause of the problem and that this was rectified and repairs undertaken to the lower storey of the building about 8-10 years ago. Another source advised that the building had been underpinned.

Photograph 29: Crack 'tell-tales' provide evidence of historical monitoring of the building's movement

3. Emily Villa has obviously had a history of movement and exhibits severe cracking. Historical information on the issues previously encountered and repairs taken should be reviewed. Decisions can then be taken on what further investigations are required and then what repairs are necessary. However, they should be assumed to be significant in this building. Underpinning may be required.

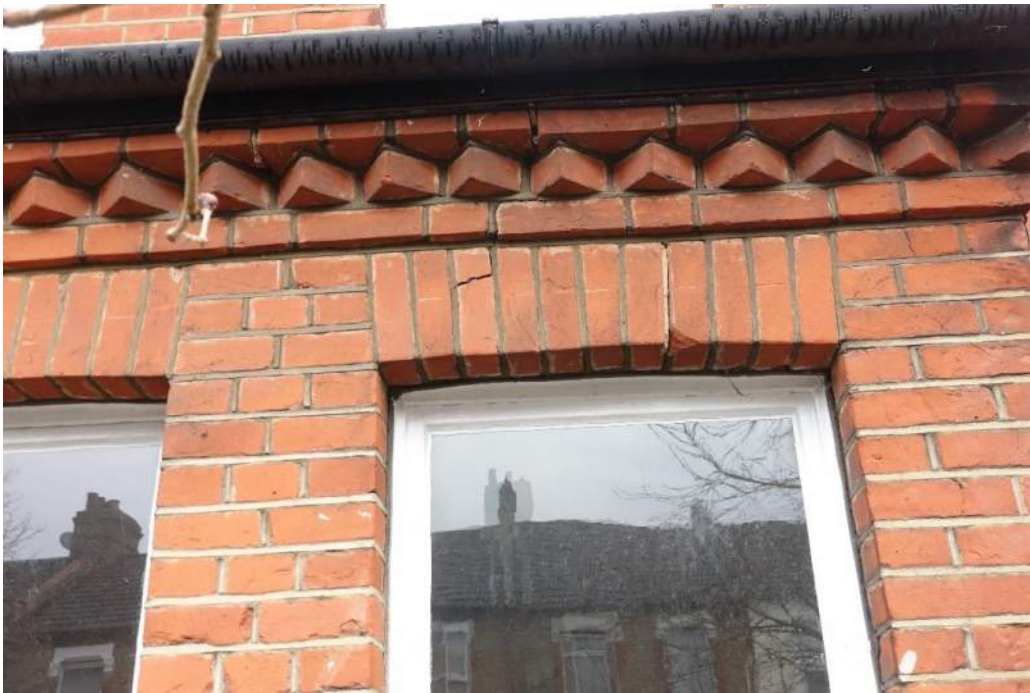
Externally cracking and evidence of movement was visible around the outside of the building.

Photograph 30: Cracked brickwork at an arch

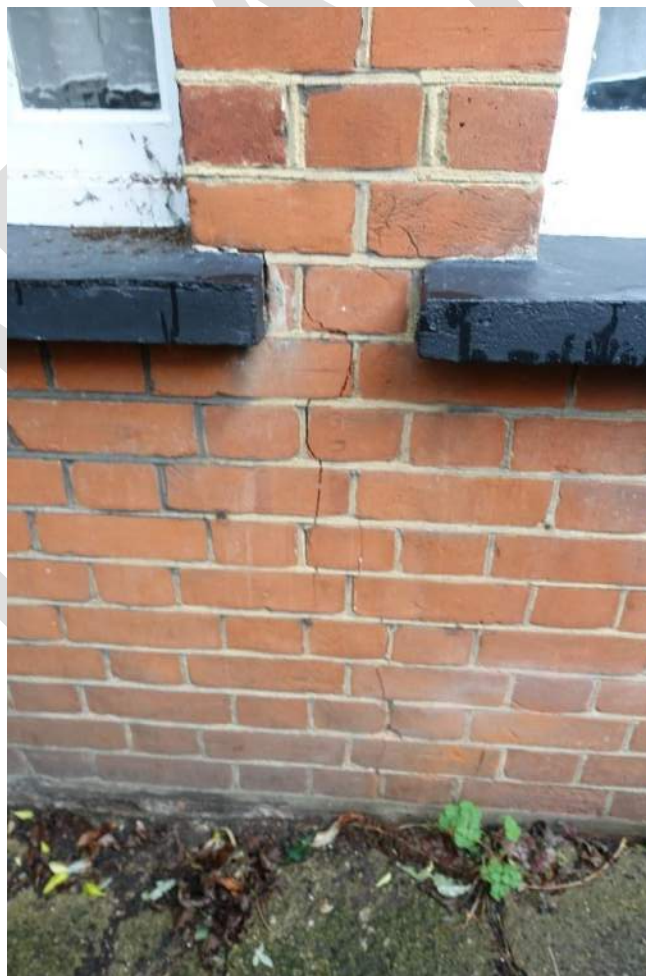
Photograph 31: Cracking, approximately 2mm wide, at the front

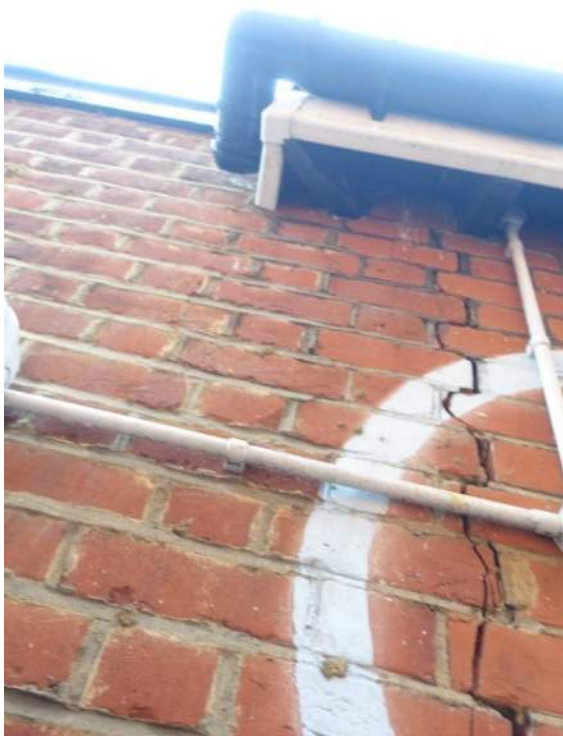
Photograph 32: Severe cracking in the north flank wall

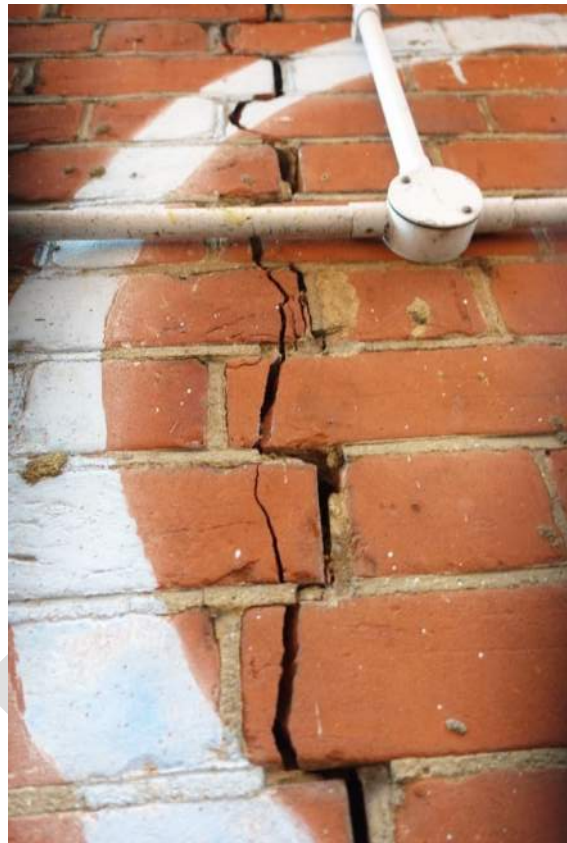
Photograph 33: Close up photograph of the cracking

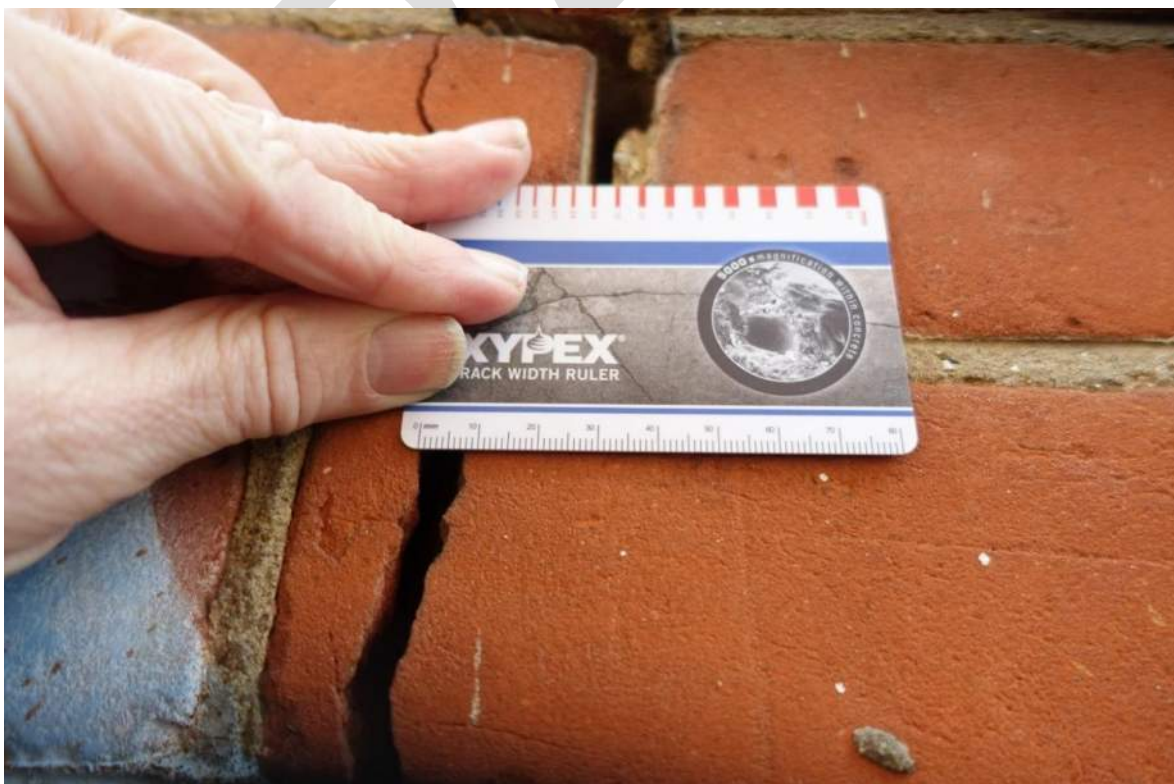
Photograph 34: The crack is 8mm wide at head height, widening to about 10mm higher up
