MertonVision
67 Clarendon Rd, Colliers Wood, London, SW19 2DX

Structural Condition Report

Project number: 2190695
Status: Information
Revision: DRAFT 26/02/2020
Date: February 2020

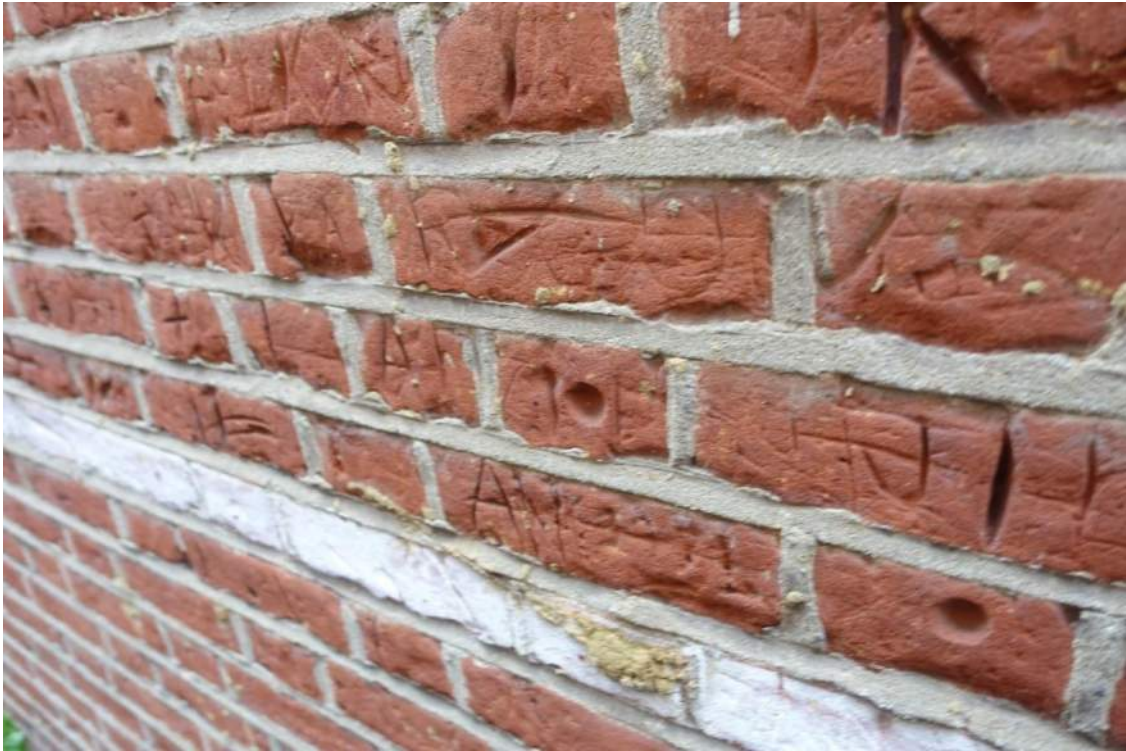
This wall has been extensively engraved by vandals.

Photograph 35: Damage to the brickwork surface by vandals

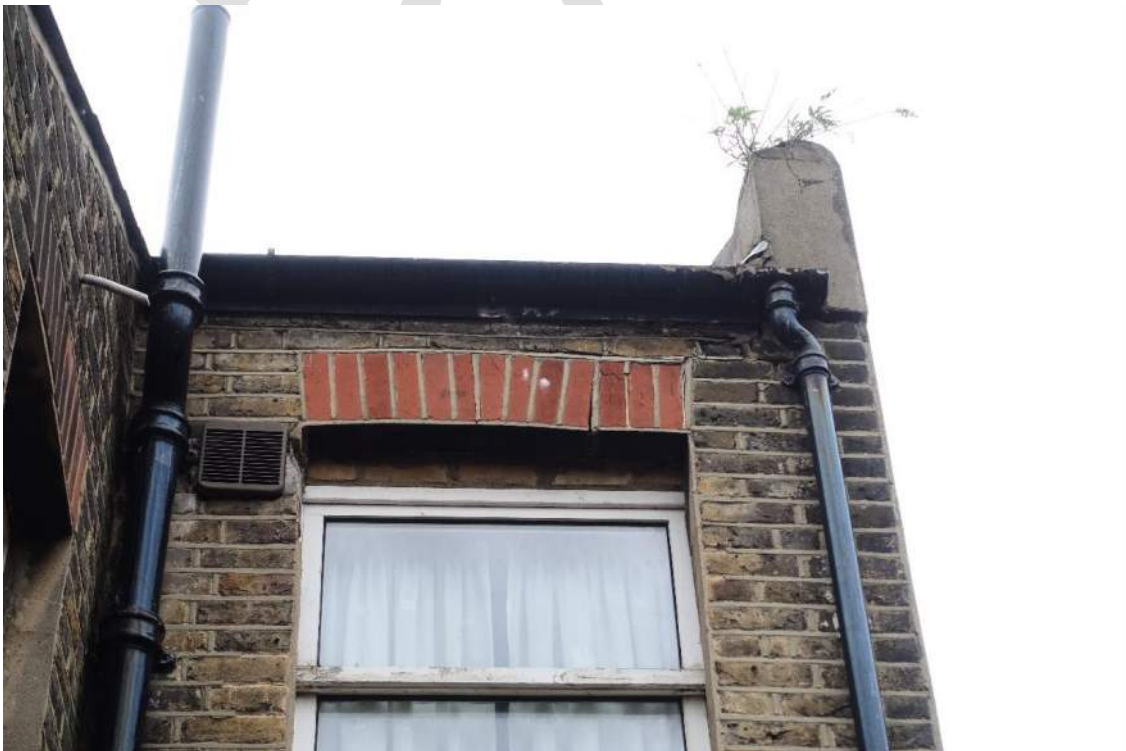
Brick arches show signs of having moved.

Photograph 36: A deformed and cracked brick arch over a window

3. Emily Villa has obviously had a history of movement and exhibits severe cracking. Historical information on the issues previously encountered and repairs taken should be reviewed. Decisions can then be taken on what further investigations are required and then what repairs are necessary. However, they should be assumed to be significant in this building. Underpinning may be required.

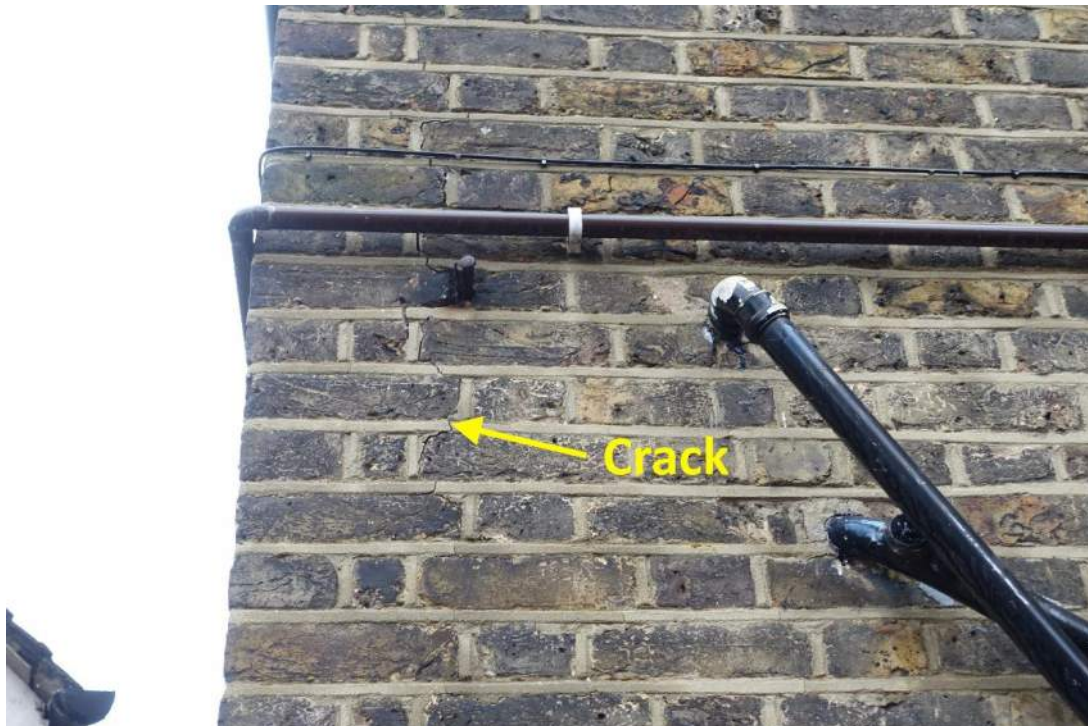
The walls have been repointed, possibly after the structural repairs.

Photograph 37: Cracking in a repointed wall

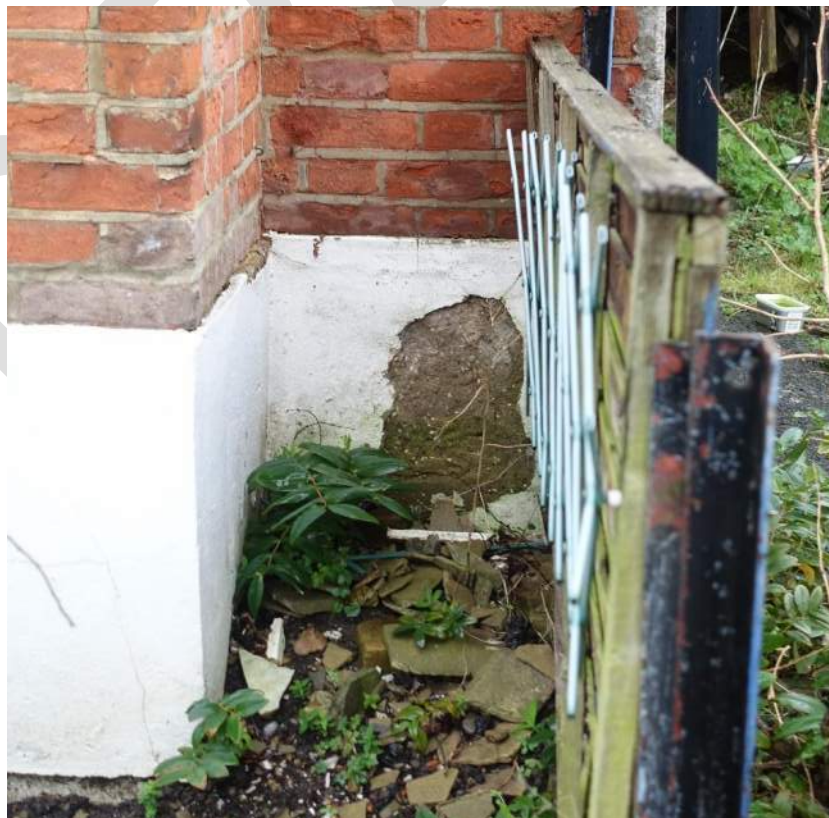
Render on the front wall has cracked some has fallen from the building.

Photograph 38: Fallen render at the front of Emily Villa

7. External render should be hammer tested and all debonded areas removed and replaced. The render should be removed locally at all cracks. If there are cracks in the substrate, these should be repaired as elsewhere; stainless steel expanded metal lathing should be fixed across the crack in the substrate before the wall is re-rendered.

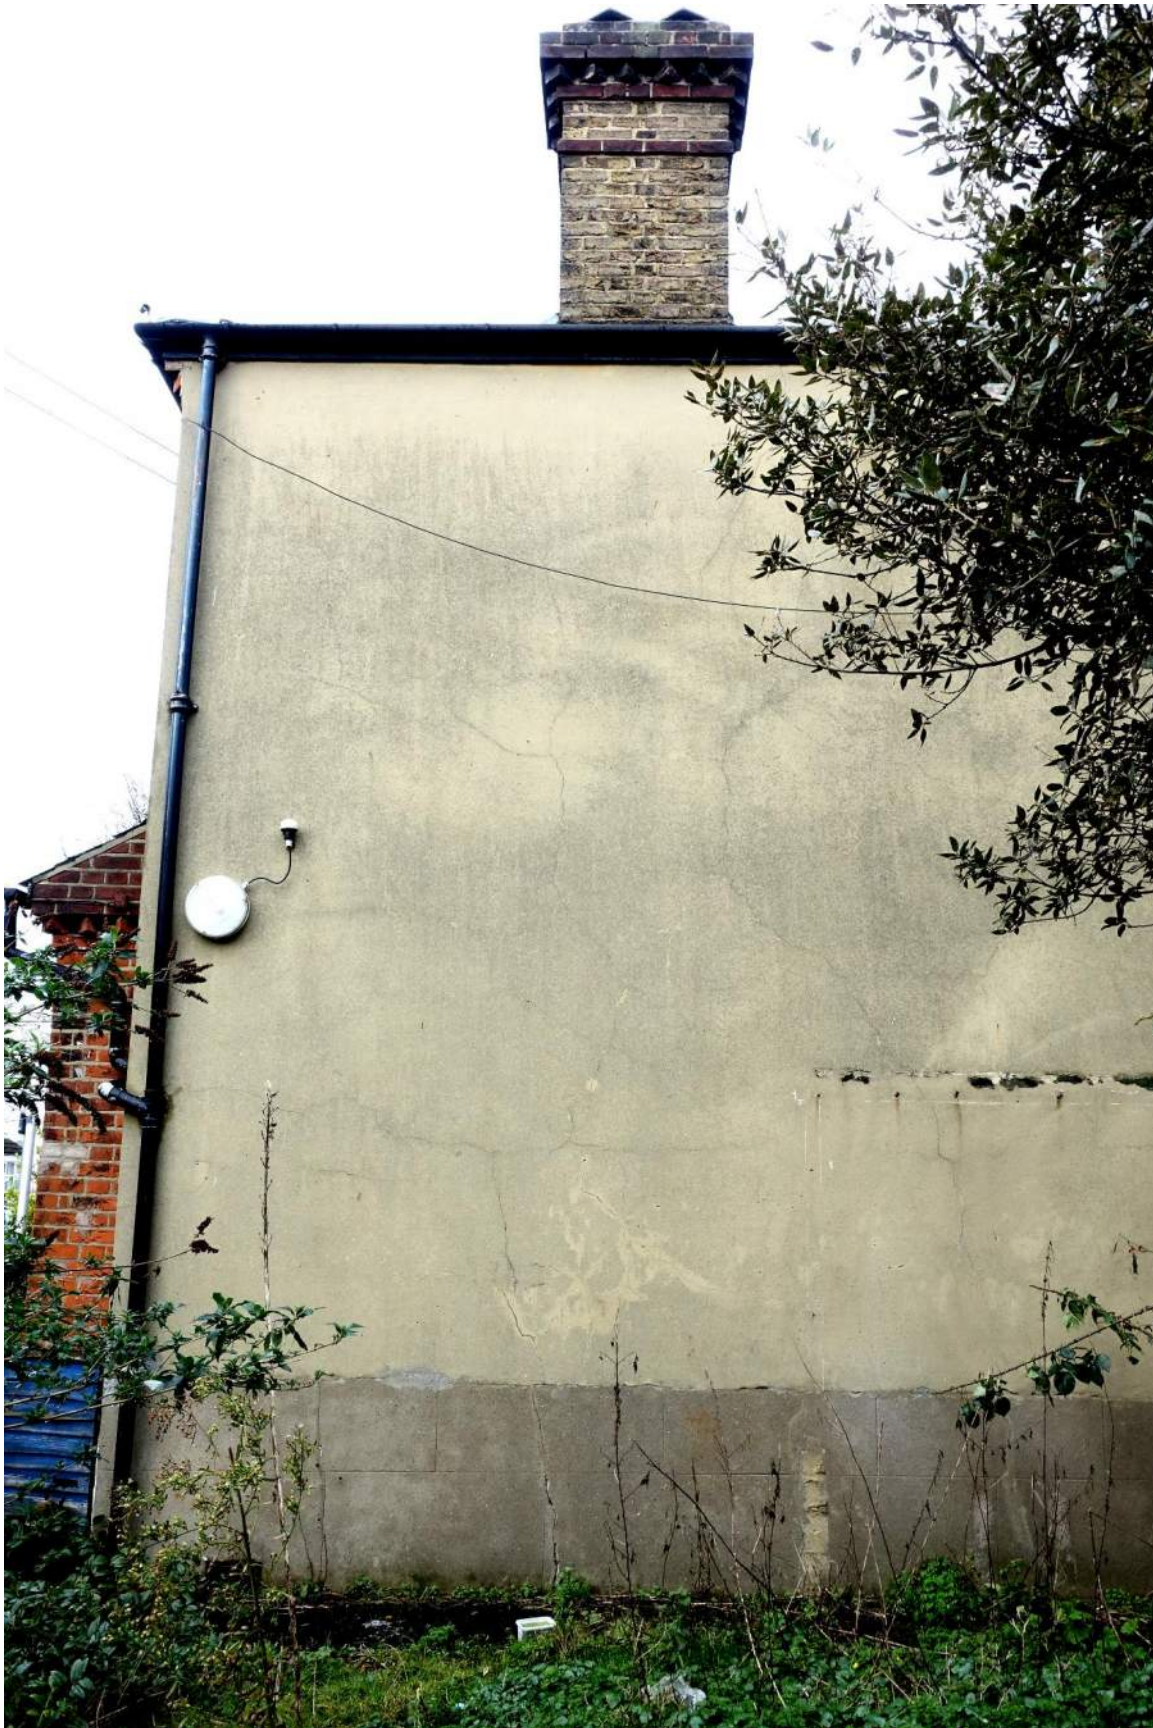
The rendered south flank wall has cracking, up to about 0.8mm wide.

Photograph 39: Cracked rendered flank wall

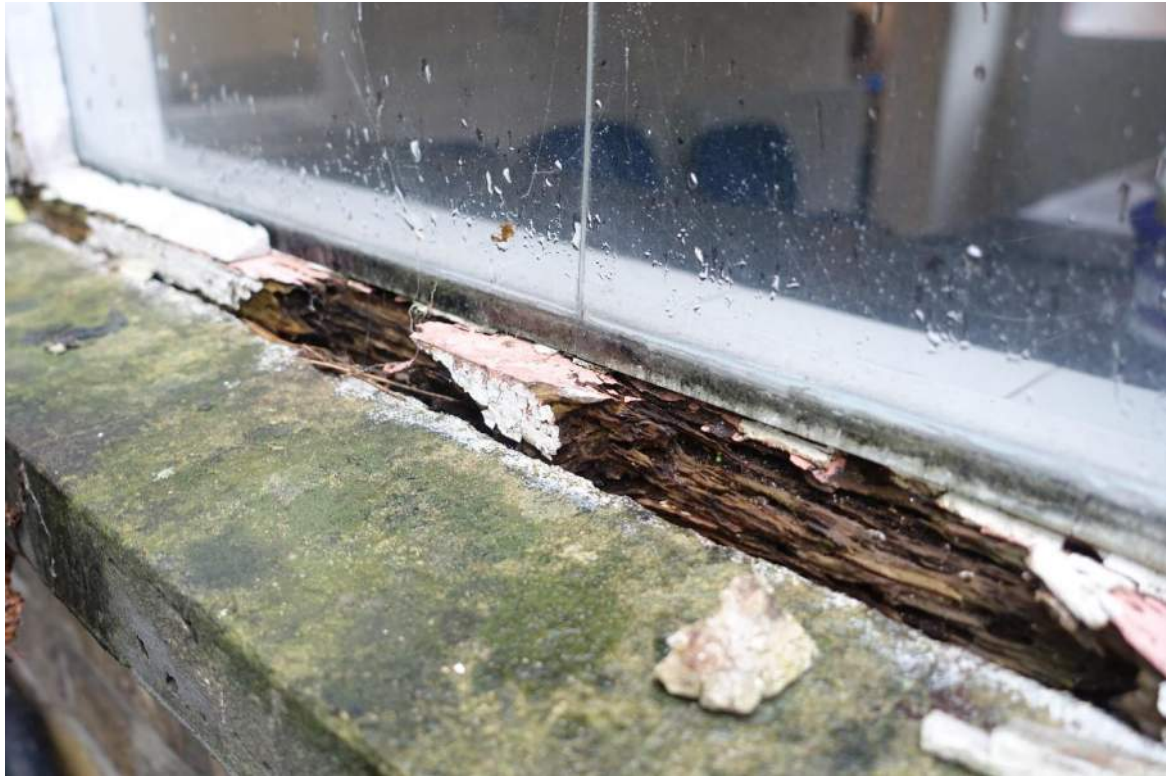
Some timber window frames are rotting.

Photograph 40: Rotten timber to the rear

10. External timber of all the buildings, windows, doors, barge boards, etc., should be reviewed by specialists and repaired or replaced as necessary. However, based on our observations, considerable repair and/or replacement is likely.

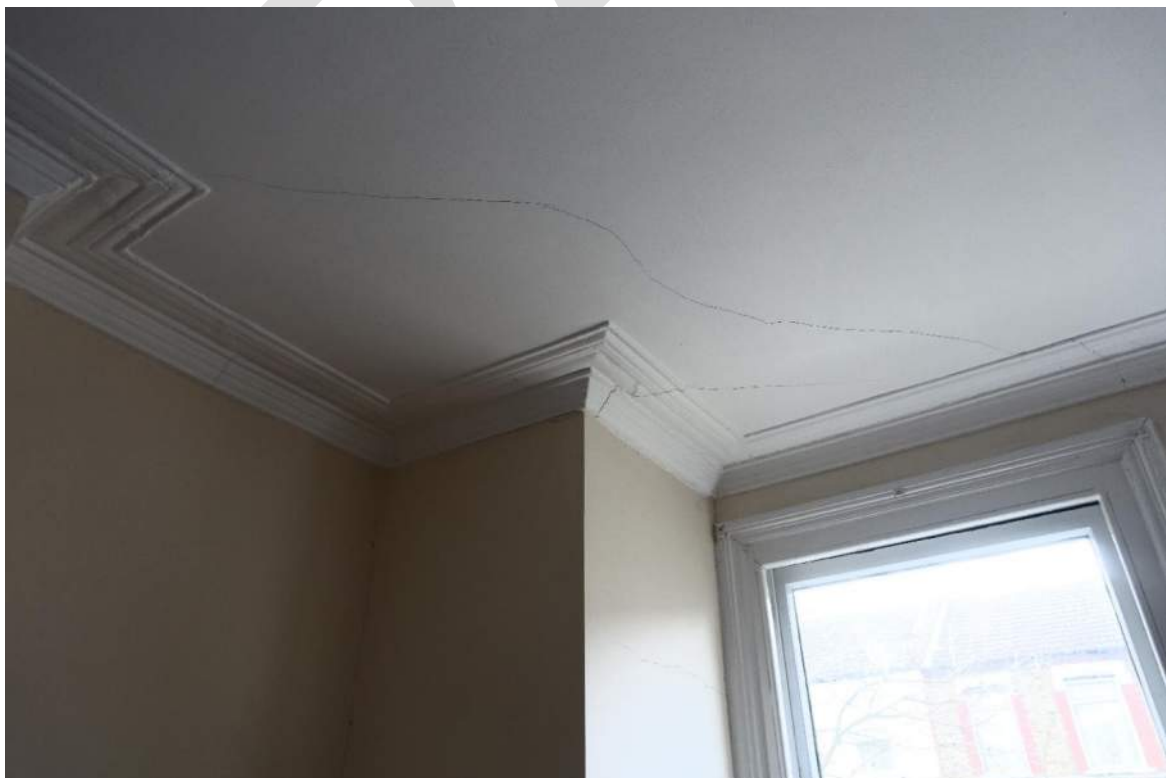
There is cracking of walls and ceilings at ground floor. Crack widths of up to 0.6mm were measured.

Photograph 41: Cracked ceiling at ground floor

4. Minor internal cracks in plastered walls can be treated by removing the plaster locally, if there is a minor crack in the masonry substrate, expanded metal can be fixed across the crack before the wall is re-plastered. More serious cracks should be repaired using HeliBars.

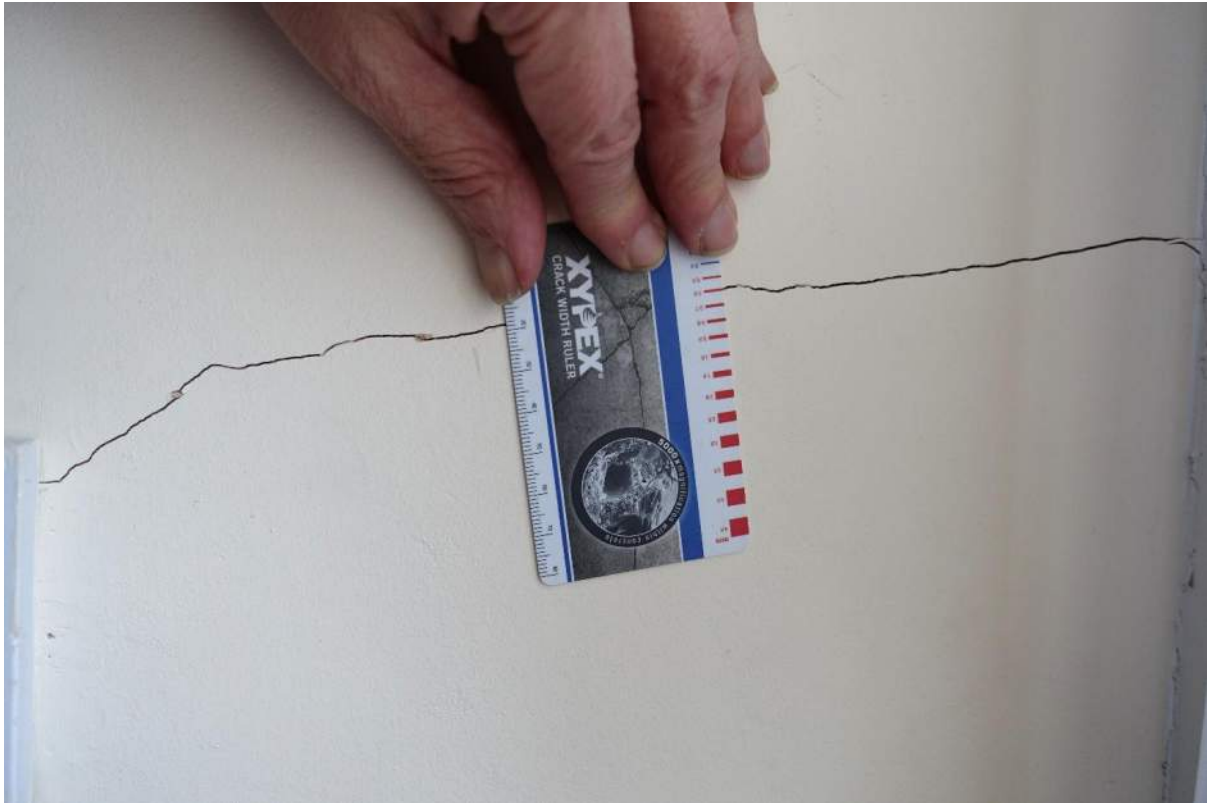
Photograph 42: A wall crack measured at 0.6mm wide

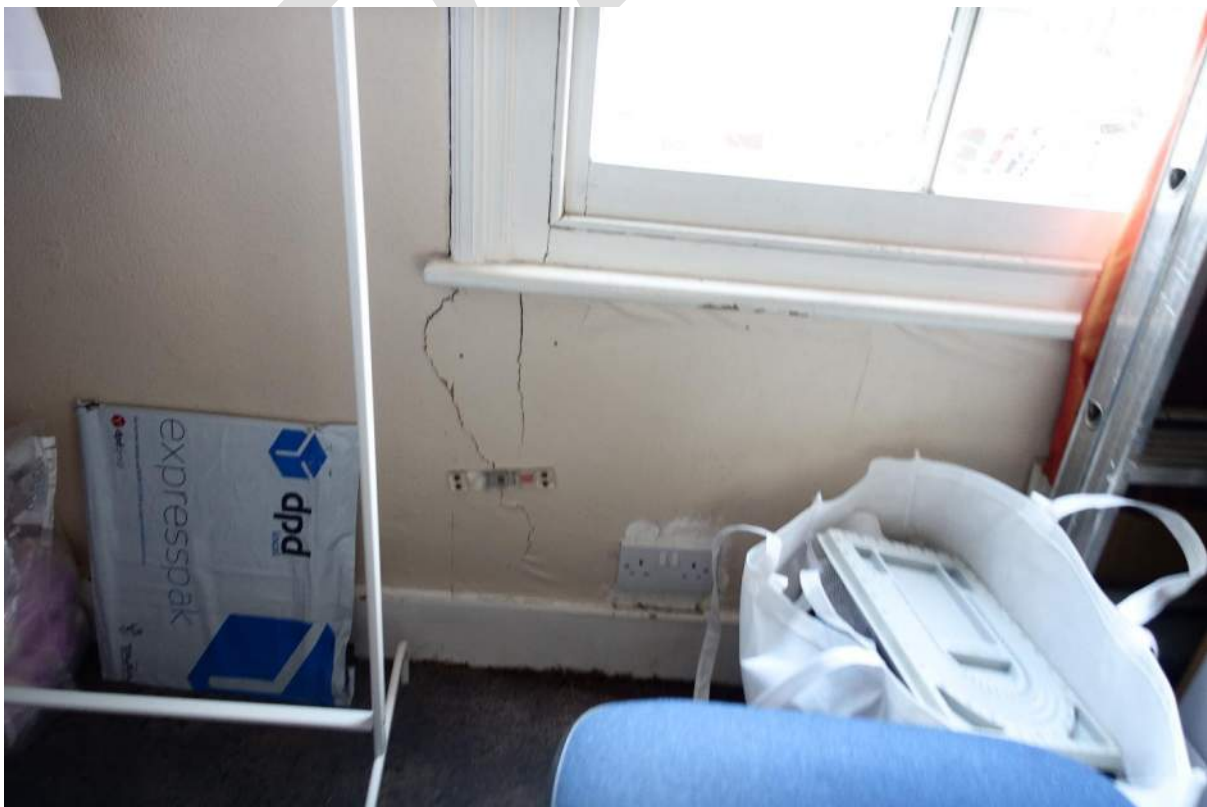
Upstairs in Emily Villa, the cracking is much worse. Staff reported difficulties in opening windows. EWP were advised that this storey was not refurbished when the public areas below were repaired.

Photograph 43: 2mm wide cracking below a first-floor window.

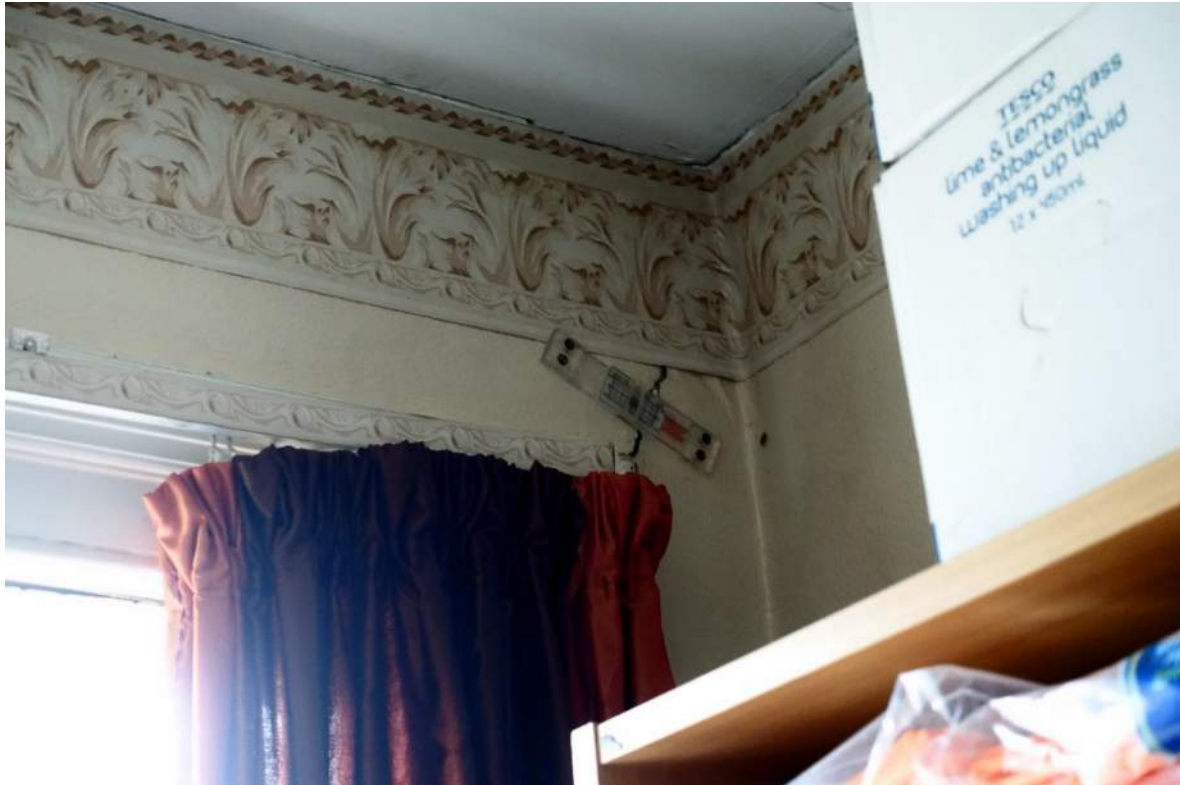
Photograph 44: Cracking above the window, with a tell-tale in place

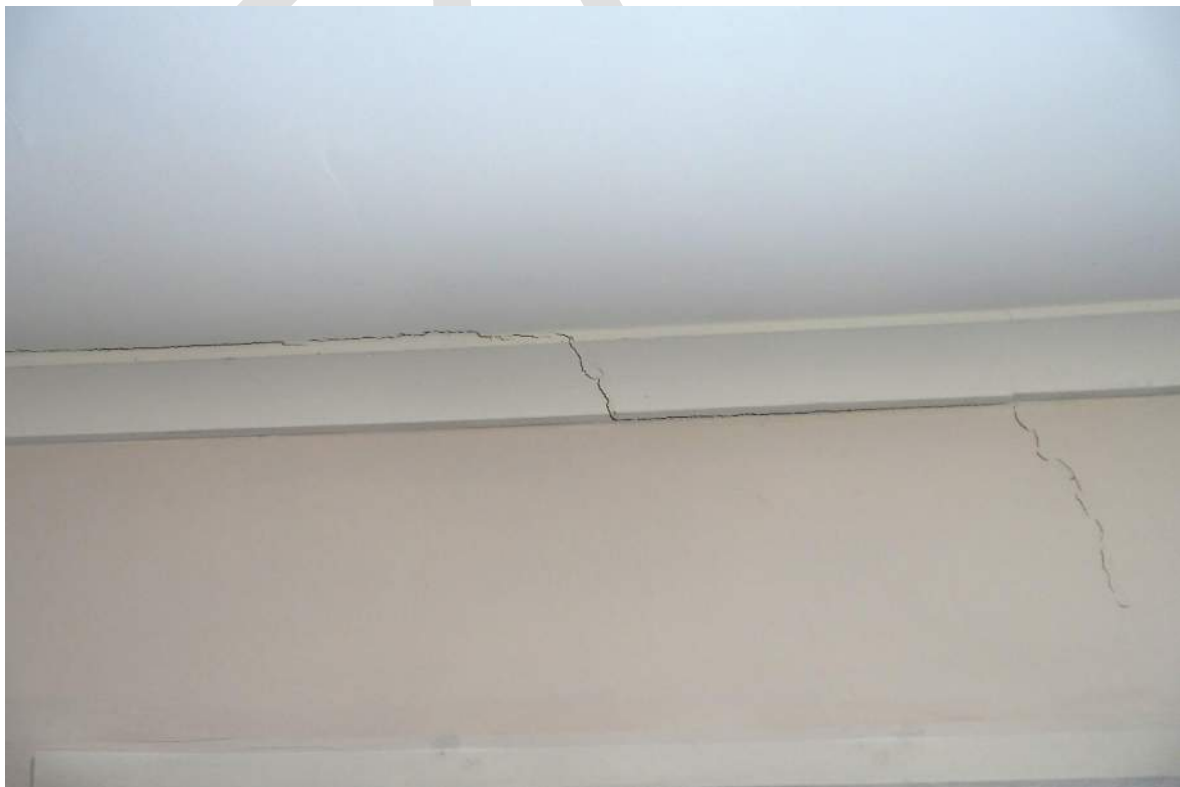
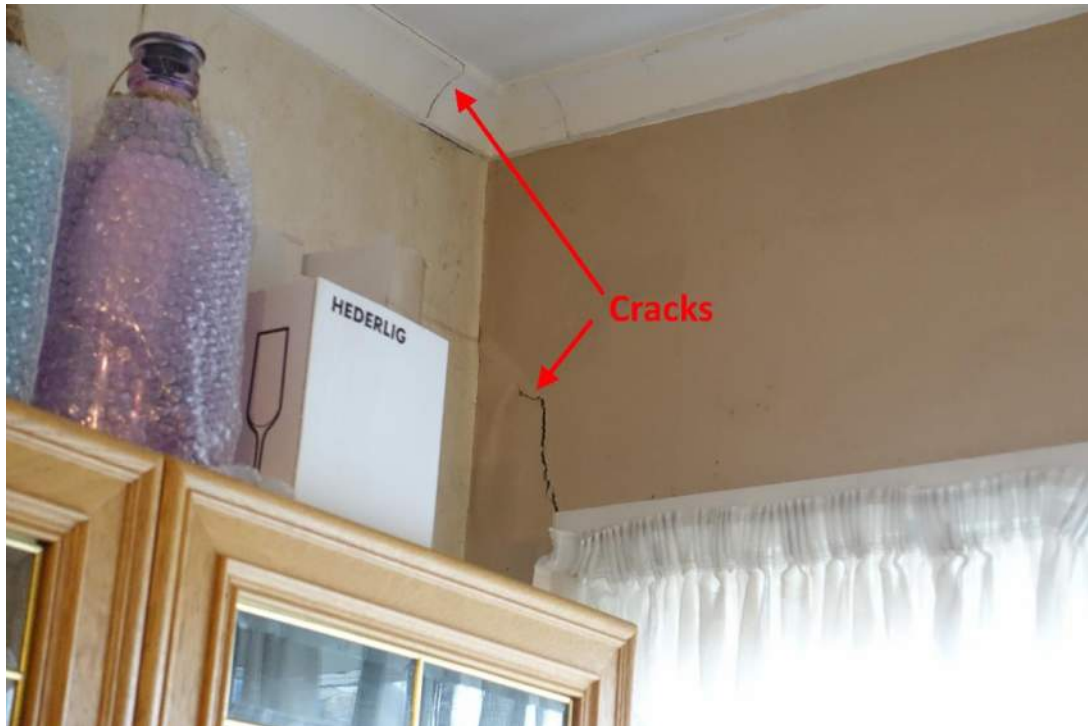
Other cracks were present in the walls and ceilings at first floor. According to the staff, some of these cracks have appeared in the last 4-5 months. If correct, this suggests that some movement is still occurring.

Photograph 45: Wall and ceiling cracking at first floor

Photograph 46: Wall and ceiling cracking at first floor

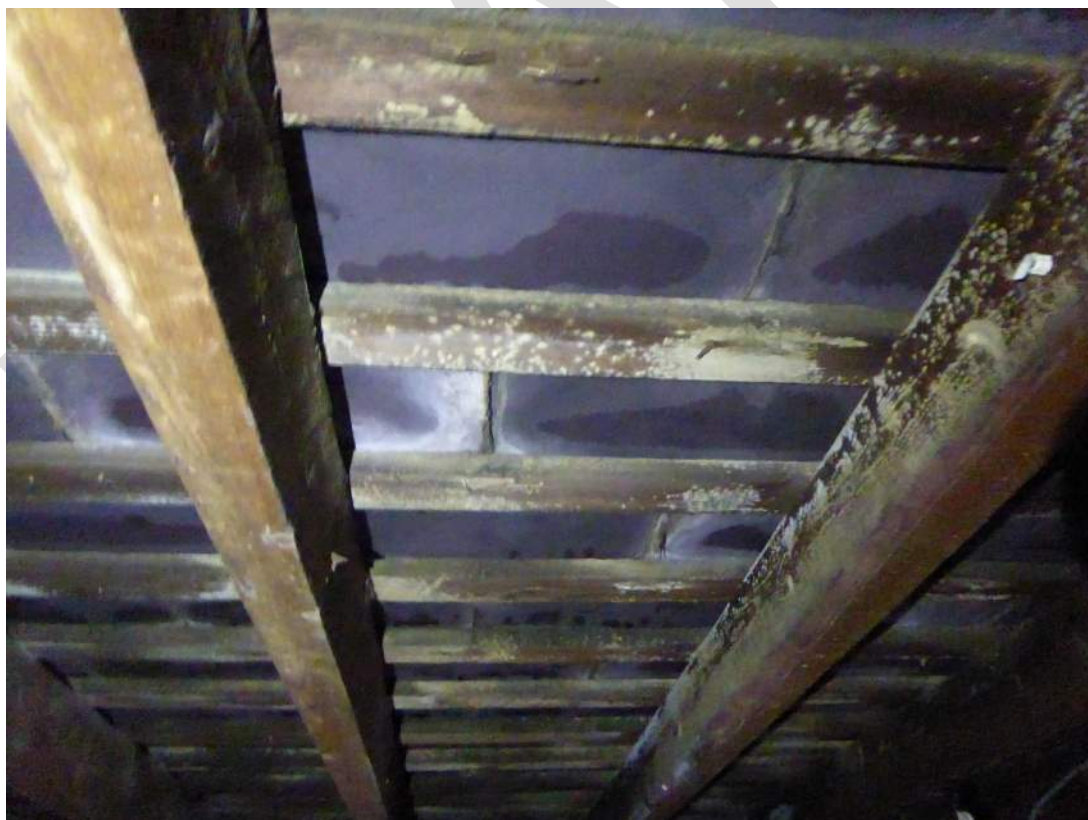
Photograph 47: Signs of damp within the roof space of Emily Villa

It can be seen that there is no sarking felt above the rafters, increasing the risk of rainwater penetration. The timbers appear to be damp and suffering from rot.

9. Where significant water leaks have already occurred, if not already undertaken, the condition of timber in the vicinity should be checked for decay. A specialist timber report should be obtained on the condition on the timber in all roof spaces. From the evidence of historical roof leaks and the photograph within the Emily Villa roof space, significant decay may be present. Timber treatment is likely to be required and significant quantities of defective timber may need to be replaced.
